# Structural Inspection Report

Client: **Surf Coast Shire Council**

Site Address: **Anglesea and Aireys Inlet  
Senior Citizens Club,  
1 McMillan Street, Anglesea**

Inspection By: **Niall Logue**  
Report Date: **28<sup>th</sup> November 2022**  
Inspection Date: **15<sup>th</sup> November 2022**  
ACA Project Ref No. **22-185**  
Report No: **Rep-02**

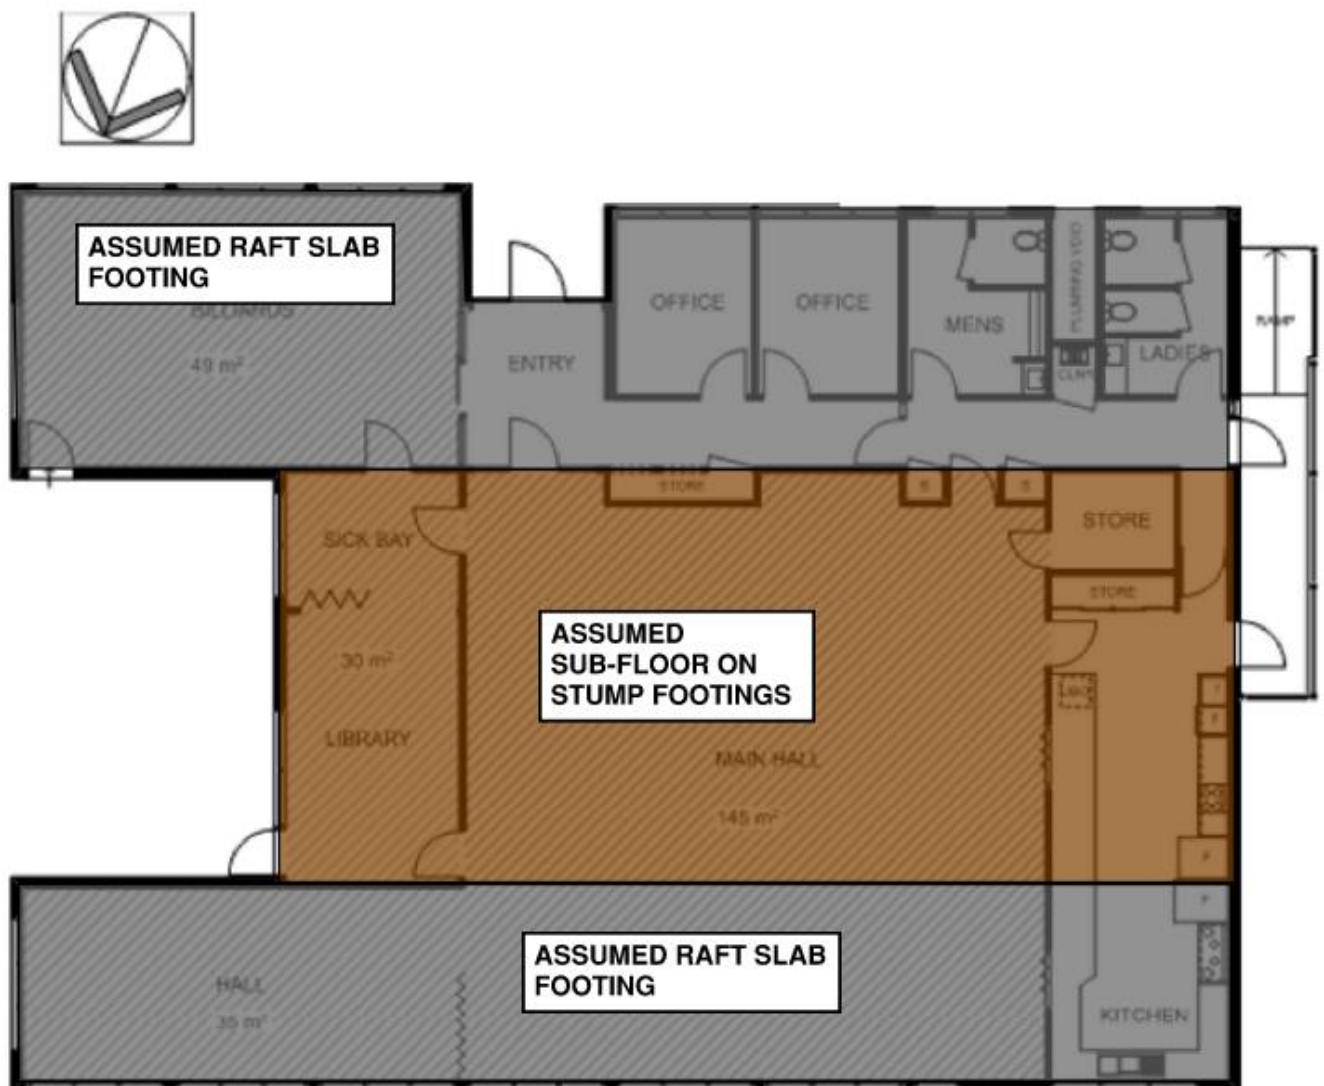
Figure 2.0 Assumed building footing arrangement

The single storey building consists of timber rafters onto timber purlins onto timber roof beams with brick veneer external walls, timber framed internal walls and what appears to be a timber sub-floor onto stumps to the middle of the building consisting of the library and sick bay, main hall and majority of the kitchen; and what is assumed to be raft slab footings to the north and south of this central strip. Refer to Figure 2.0 below for footings assumptions.

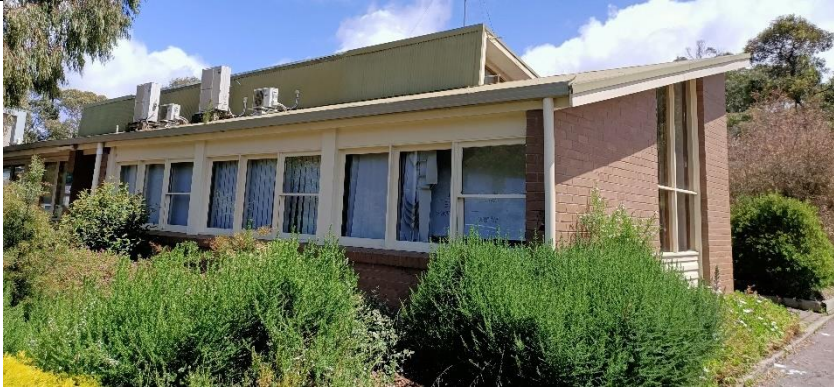
| ITEM | | ACCESS | CONDITION RATING | CONDITION DESCRIPTION | RECOMMENDED WORKS | PHOTO No. |
|---|---|---|---|---|---|---|
| 1 | Roofing, flashing | P <sup>(1)</sup> | 3-4 | No obvious signs of rust but very limited access for inspection. Water damage at roof penetration noted in Geelong Pest Control report suggests other penetrations may be leaking. Degradation noted to majority of timber fascia boards and flashing. Vegetation was observed growing in gutters suggesting lack of regular maintenance. | Recommend all roof areas are cleared and cleaned of all debris, detritus and lichen. Investigate seals around all roof penetrations. All flashings to be inspected by plumber. All degraded fascia boards and soffit linings to be replaced. All roofing, flashing, gutters and downpipes should be inspected regularly for damage, build-up of detritus or leaks and repaired as required. | 1, 2 |

| Photo | Notes |
|---|---|
| | <p>Photo 1:<br/>Roofing to south of building with vegetation in gutters, degraded fascia boards, and flashing. Possible leaks to service penetrations.</p> |

The roof requires further investigation to repair all seals to penetrations and flashing. All gutters require inspection and clearing.

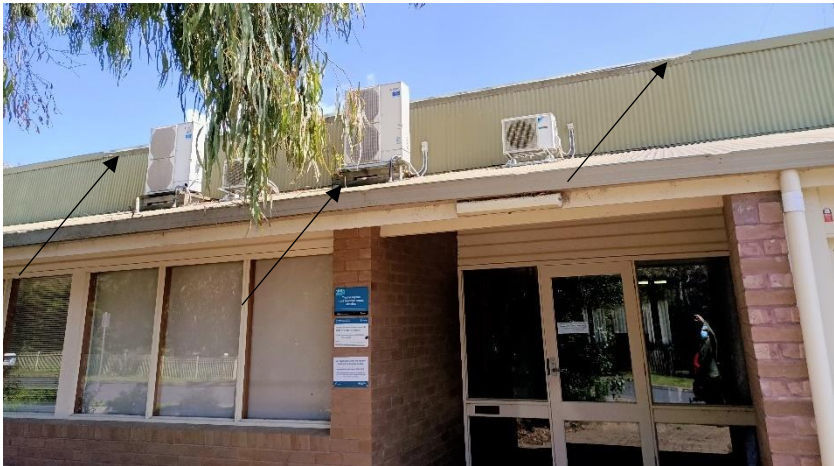
| Photo | Notes |
|---|---|
| | <p>Photo 2:<br/>Roofing to south of building with degraded flashing. Possible leaks to service penetrations.</p> |

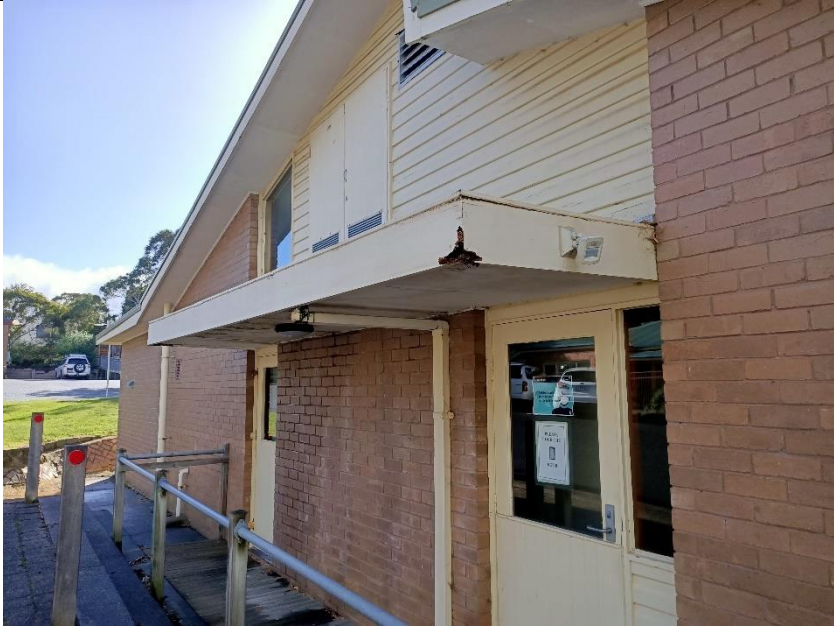
| ITEM | | ACCESS | CONDITION RATING | CONDITION DESCRIPTION | RECOMMENDED WORKS | PHOTO No. |
|---|---|---|---|---|---|---|
| 2 | Canopy to west wall | P <sup>(1)</sup> | 5 | Extensive degradation to timber elements, eaves beam rotten. Water staining to soffit and masonry wall suggests ongoing water leaks. | Recommend demolition within 6-12 months. Recommend two free corners are propped until demolition works take place. | 3, 4, 5, 6 |

| Photo | Notes |
|---|---|
| A photograph showing the exterior of a building with a brick wall and a white canopy over the entrance. A ramp with a metal handrail is visible on the left side of the entrance. | Photo 3:<br>Canopy to west wall to be removed and replaced. |

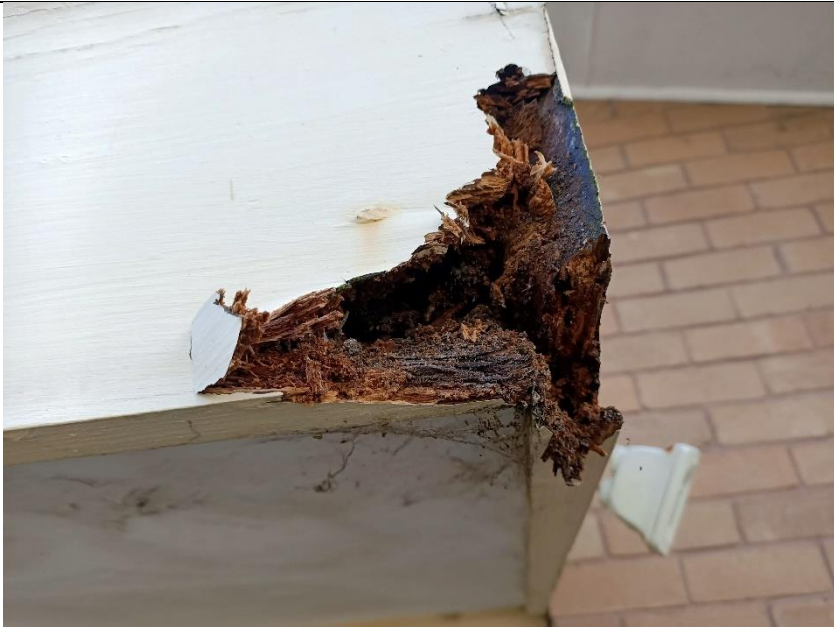
| Photo | Notes |
|---|---|
| A close-up photograph of a wooden fascia board that is severely rotted and crumbling. The wood is dark brown and splintered, with a large section missing, revealing the underlying structure. | Photo 4:<br>Rotten fascia boards to canopy. |

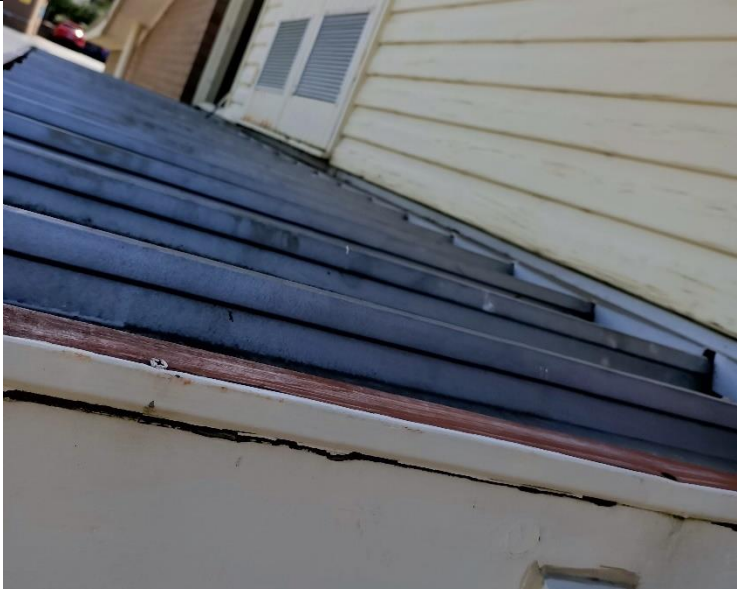
| Photo | Notes |
|---|---|
| | <p>Photo 5:<br/>Canopy not weathertight.</p> |

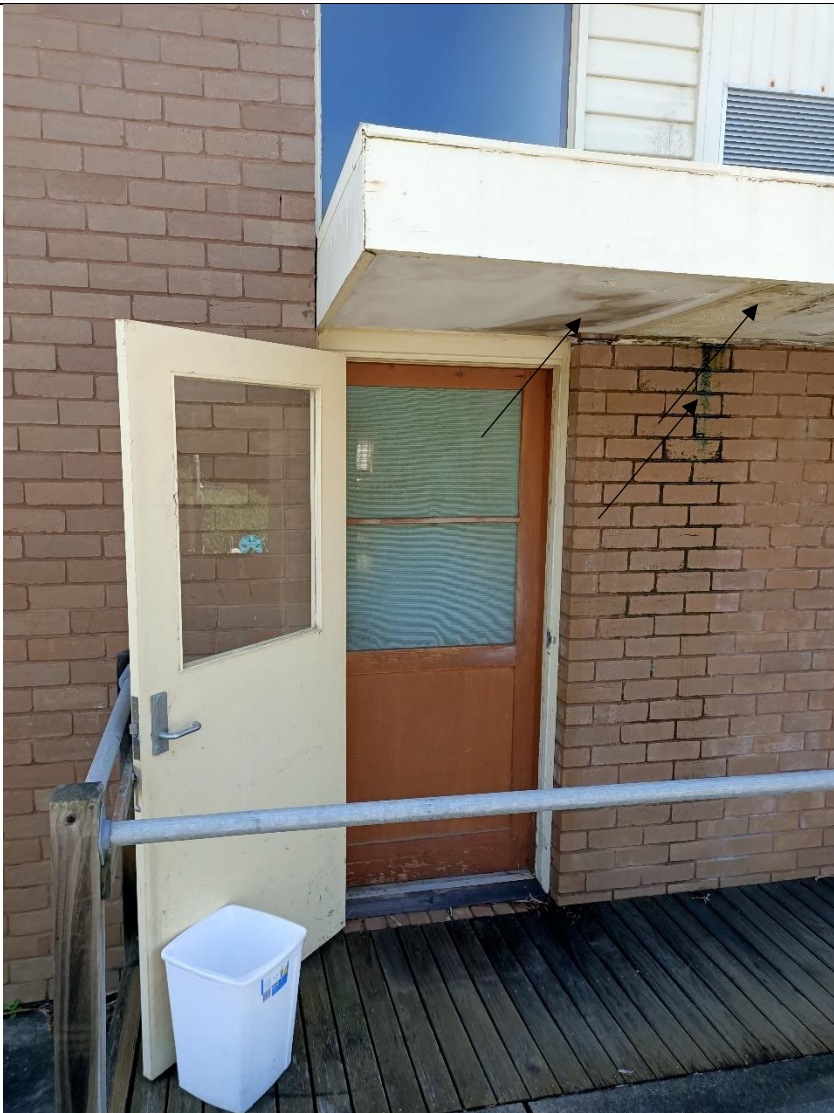
| Photo | Notes |
|---|---|
| | <p>Photo 6:<br/>Evidence of long term water leaks to canopy, staining to soffit and masonry.</p> |

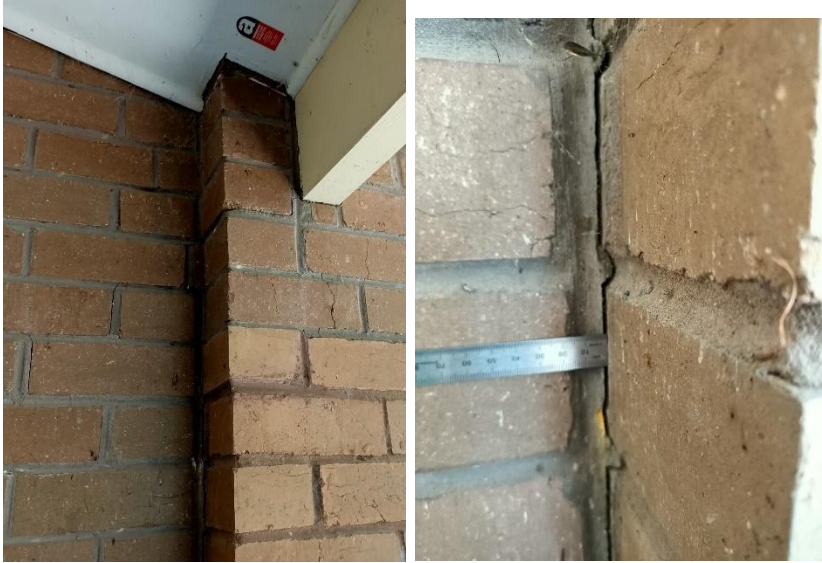
| ITEM | | ACCESS | CONDITION RATING | CONDITION DESCRIPTION | RECOMMENDED WORKS | PHOTO No. |
|---|---|---|---|---|---|---|
| 3 | External Wall Cladding | R <sup>(1)</sup> | 3-5 | Brick veneer walls in poor condition in isolated areas. Cracks evident to west of plumbing void access door on south wall, under roof beam to south entry, above AJ on north elevation. Articulation joints not in accordance with industry standards outlined in Cement Concrete & Aggregates Australia (CCAA) technical guidance document TN61. Movement evident to articulation joints to north, east and west elevation where it has opened at the top and is pinched at the bottom. Degradation to timber weatherboard cladding to west elevation. External ground levels built up over weatherboard along east elevation likely resulting in degradation of cladding. Sub-floor ventilation not in accordance with NCC Volume 2 which requires min 6000mm <sup>2</sup> per m of wall, existing vents insufficient and | Remove and replace all degraded timber fascia boards, cladding. Remove garden beds from east wall. Regrade ground to fall away from footings min 50mm over 1000mm with area suitably drained to collect and drain surface water to LPOD.<br>The lack of adequate ventilation to sub-floor areas is only one of a number of issues requiring attention related to the sub-floor. The remaining issues will be discussed further in the report under item 9. Considering all of the issues related to the sub-floor, the concluding recommendation is that all sub-floor areas are removed and reinstated with a concrete raft slab footing. | 7, 8, 9, 10, 11, 12, 13, 14, 15, 16, 17, 18, 19, 20, 21, 22, 23, 24, 25 |

| Photo | Notes |
|---|---|
| | <p>Photo 7:</p> <p>Cracking to underside of roof beam at north entry extended down wall measuring up to 2mm wide. Classified as Damage Category 2 or 'Slight' in accordance with AS 2870 Table C1.</p> |

Articulation joints are recommended to all openings greater than 1800mm wide on each elevation. Remedial works are required to all existing articulation joints and to repair existing cracks.

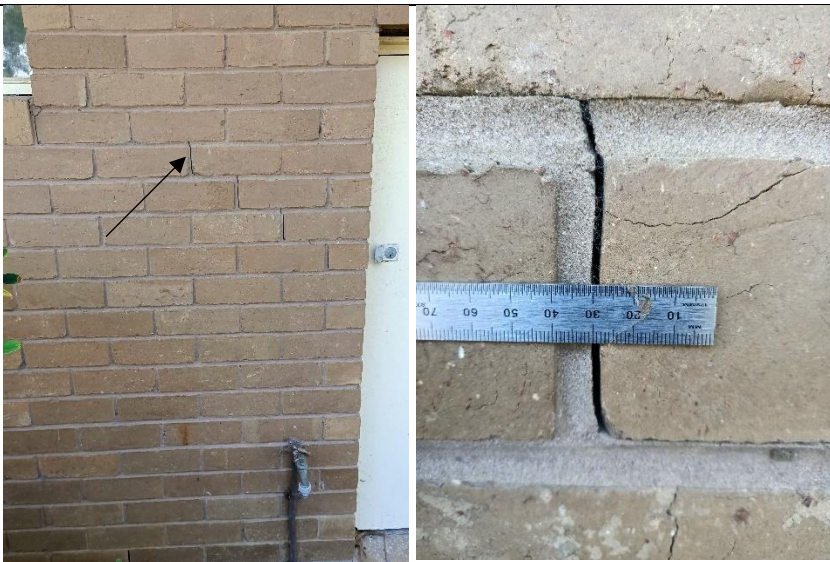
| Photo | Notes |
|---|---|
| | <p>Photo 8:</p> <p>Cracking to west of plumbing void access door on south wall measuring up to 2mm wide. Classified as Damage Category 2 or 'Slight' in accordance with AS 2870 Table C1.</p> |

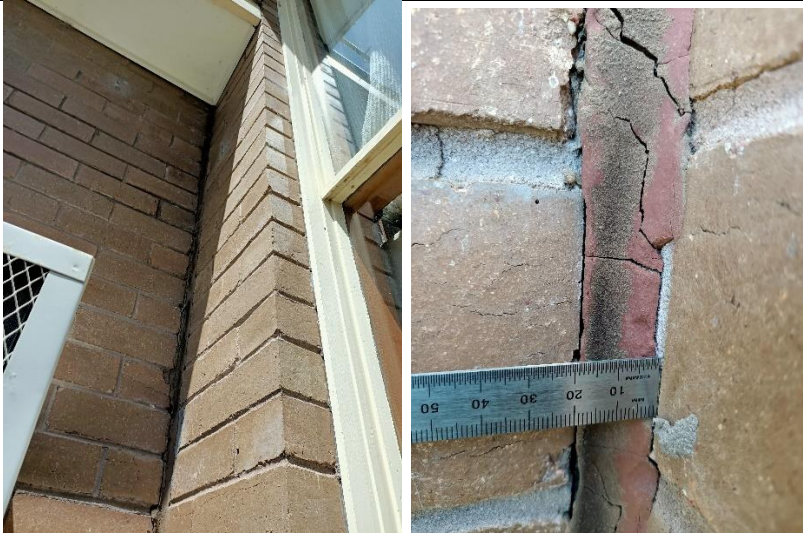
| Photo | Notes |
|---|---|
| | <p>Photo 9:<br/>Evidence of long term movement to east of sick bay. Articulation joint (AJ) measuring up to 20mm wide. Original AJ width assumed to be industry standard 10mm for single story building. Classified as Damage Category 3 or 'Moderate' in accordance with AS 2870 Table C1.</p> |

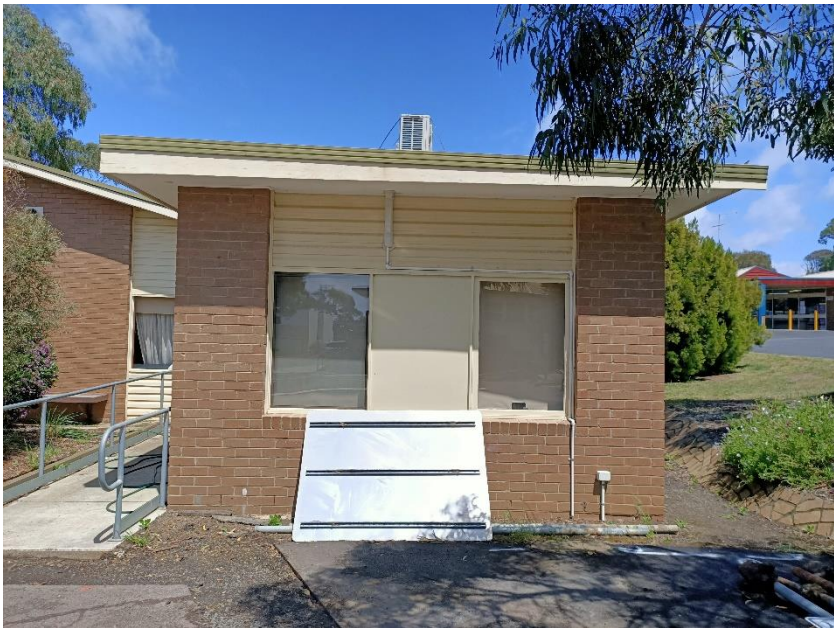
| Photo | Notes |
|---|---|
| | <p>Photo 10:<br/>No articulation joint to window on east elevation greater than 1800mm wide.</p> |

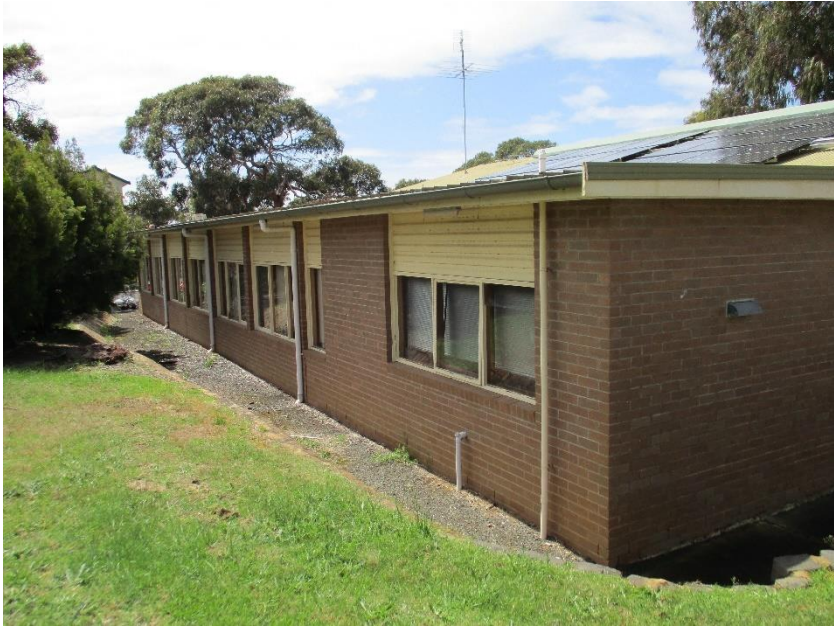
| Photo | Notes |
|---|---|
| | <p>Photo 11:<br/>Insufficient articulation joints to windows on north elevation greater than 1800mm wide.</p> |

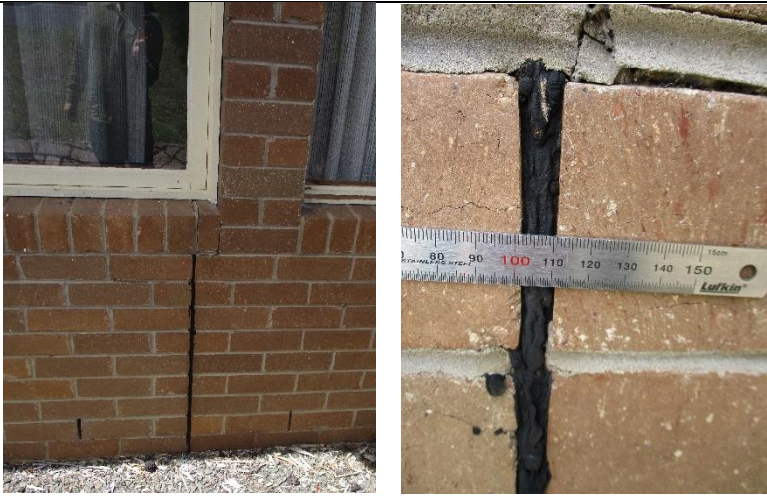
| Photo | Notes |
|---|---|
| | <p>Photo 12:<br/>Articulation joint on north elevation not in line with pier between windows resulting in crack at window sill. Articulation joint has pinched at top due to footing movement.</p> |

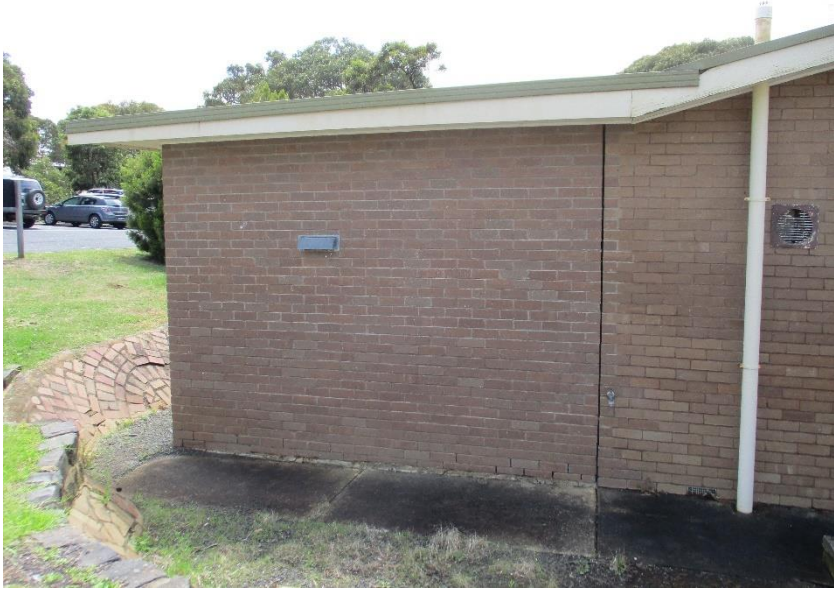
| Photo | Notes |
|---|---|
| | <p>Photo 13:<br/>Articulation joint to north of west kitchen wall opened at top, pinched at bottom due to footing movement.</p> |

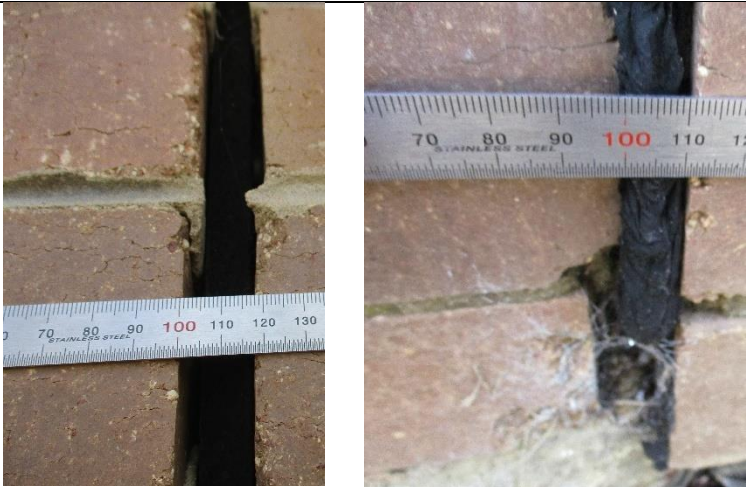
| Photo | Notes |
|---|---|
| | <p>Photo 14:<br/>Articulation joint to north of west kitchen wall opened at top to 20mm, pinched at bottom due to footing movement. Sealant not full height allowing water ingress.</p> |

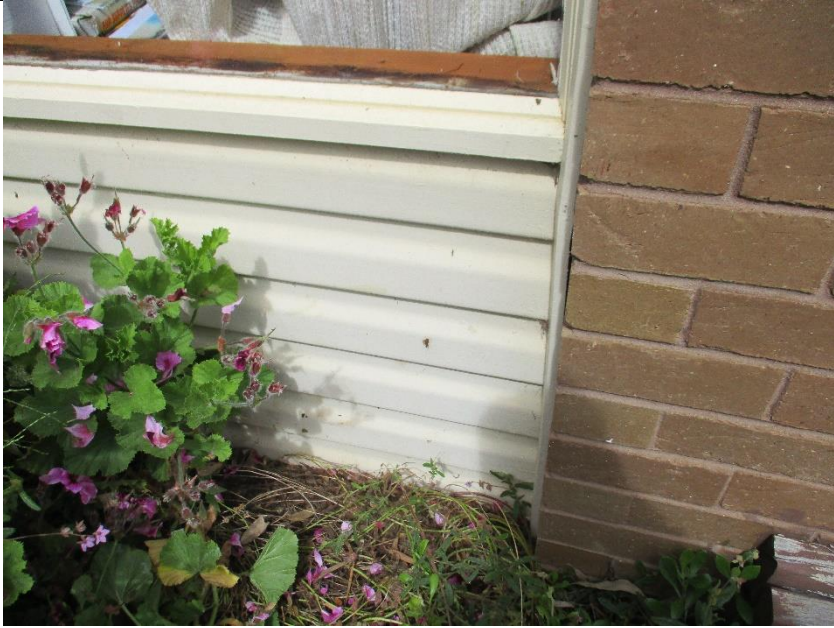
| Photo | Notes |
|---|---|
| | <p>Photo 15:<br/>Planting built up above timber cladding to east wall. Likely obstructing sub-floor ventilation in adjacent masonry panels.</p> |

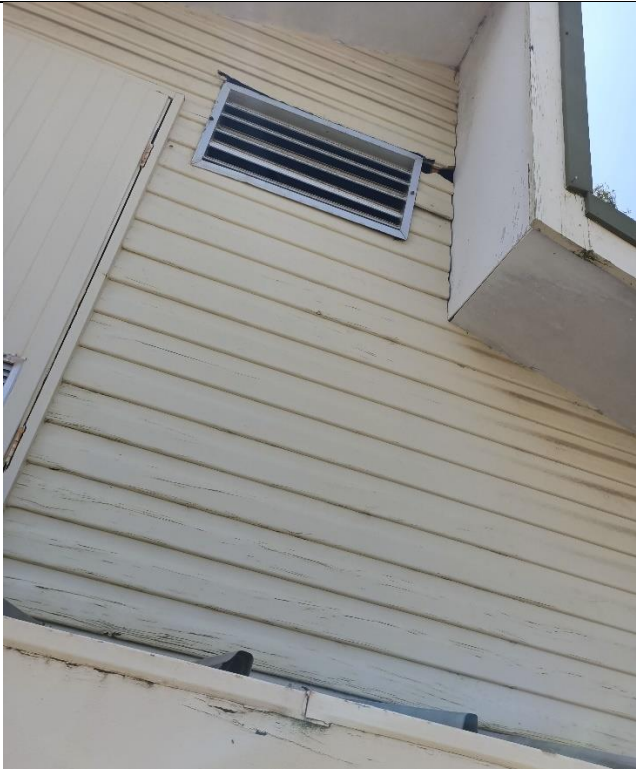
| Photo | Notes |
|---|---|
| | <p>Photo 16:<br/>Degradation of timber cladding and fascia boards to west wall above canopy. Not weather tight.</p> |

The canopy to the west wall, fascia boards, timber cladding to the west wall and east wall of the sick bay and access deck to the west wall are recommended to be replaced.

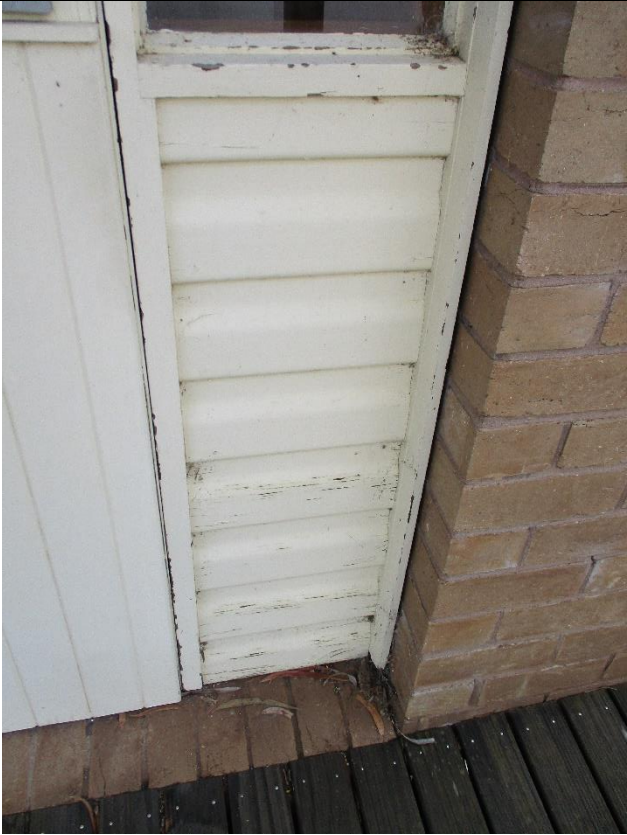
| Photo | Notes |
|---|---|
| | Photo 17:<br>Degradation to timber cladding to west wall. |

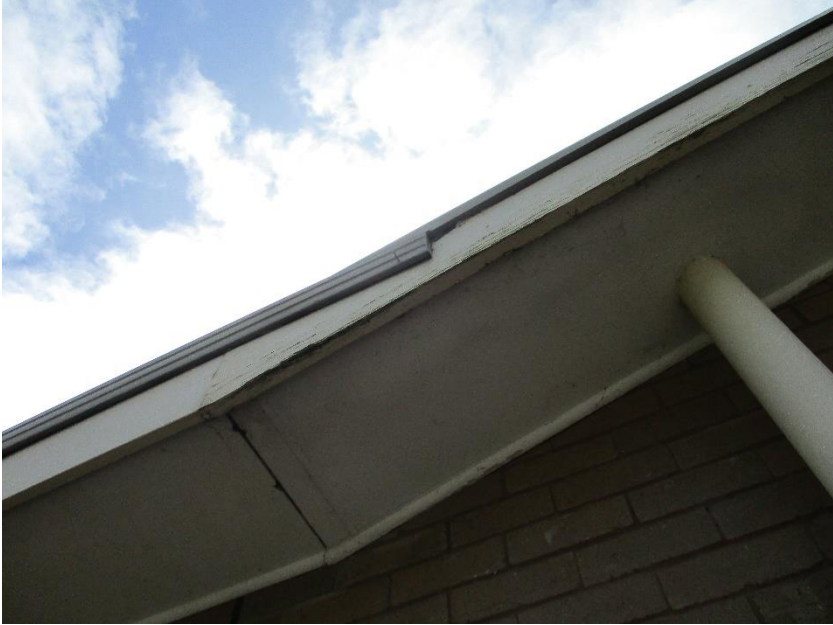
| Photo | Notes |
|---|---|
| | Photo 18:<br>Degradation to fascia boards to west wall. |

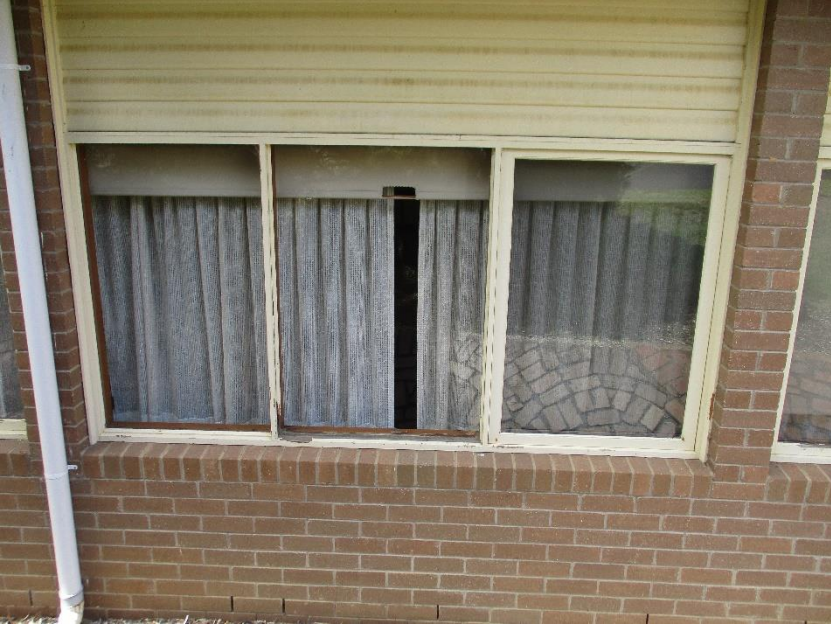
| Photo | Notes |
|---|---|
| | <p>Photo 19:</p> <p>No articulation joints to windows on north elevation greater than 1800mm wide. Timber window frame in poor condition.</p> |

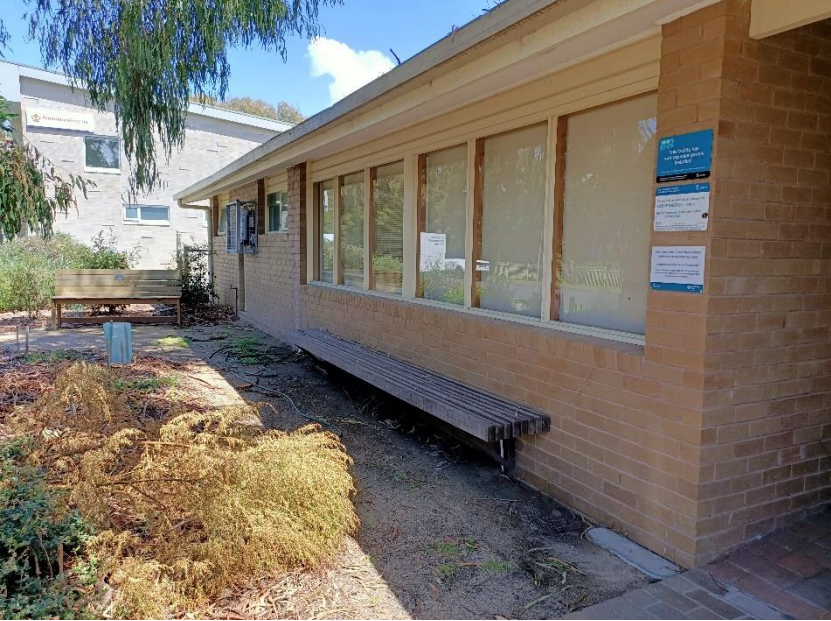
| Photo | Notes |
|---|---|
| | <p>Photo 20:</p> <p>No articulation joints to windows on south elevation greater than 1800mm wide.</p> |

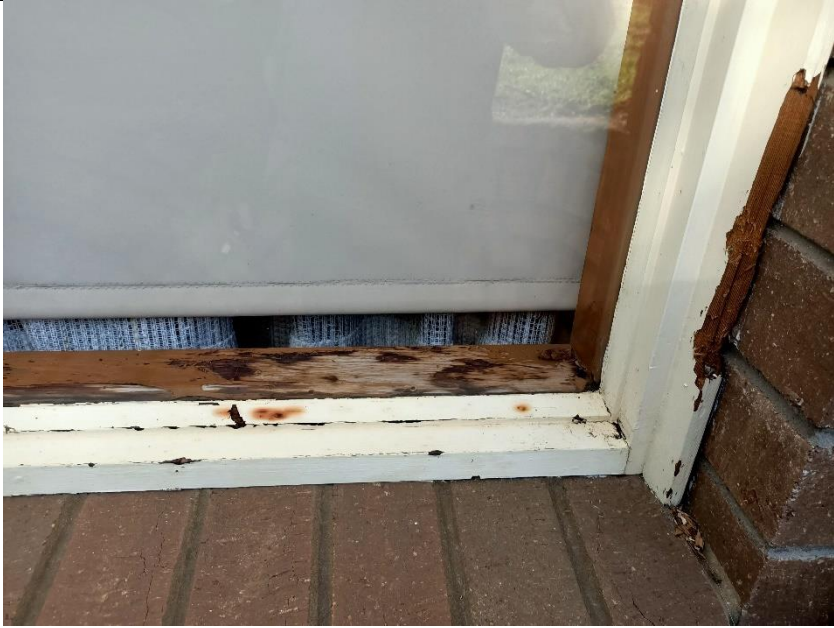
| Photo | Notes |
|---|---|
| A close-up photograph of a timber window frame. The frame is made of light-colored wood and shows significant signs of decay, including dark staining and structural weakening. It is set against a white wall, and a brick wall is visible to the right. The floor is covered with brown tiles. | <p>Photo 21:<br/>Timber window frame to north wall in poor condition.</p> |

The window frames are very near the end of their life and are expected to require replacement within 12-24 months.

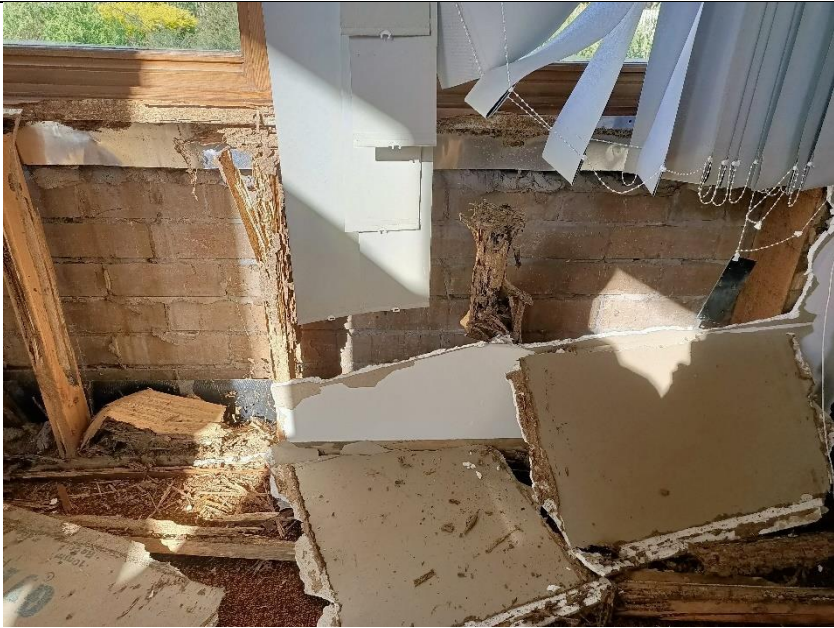
| Photo | Notes |
|---|---|
| A photograph showing extensive damage to a wall and window frame. The wall is made of brick and has been severely compromised by termite damage, with large sections of the outer layer missing, exposing the internal structure. Debris, including wood and plaster, is scattered on the floor. A window with white blinds is visible in the background. | <p>Photo 22:<br/>Extensive termite damage to clad frame on south wall of billiards room. Structural integrity to wall lost.</p> |

The extent of damage to the billiards room and library and sick bay rooms is such that demolition of these rooms is recommended within 12 months. The extent of damage to the sub-floor to the main hall and the level of disruption that would result from the reinstatement of a new sub-floor in accordance with the requirements of the NCC is such that a raft slab footing would be considered a better long term solution for the building.

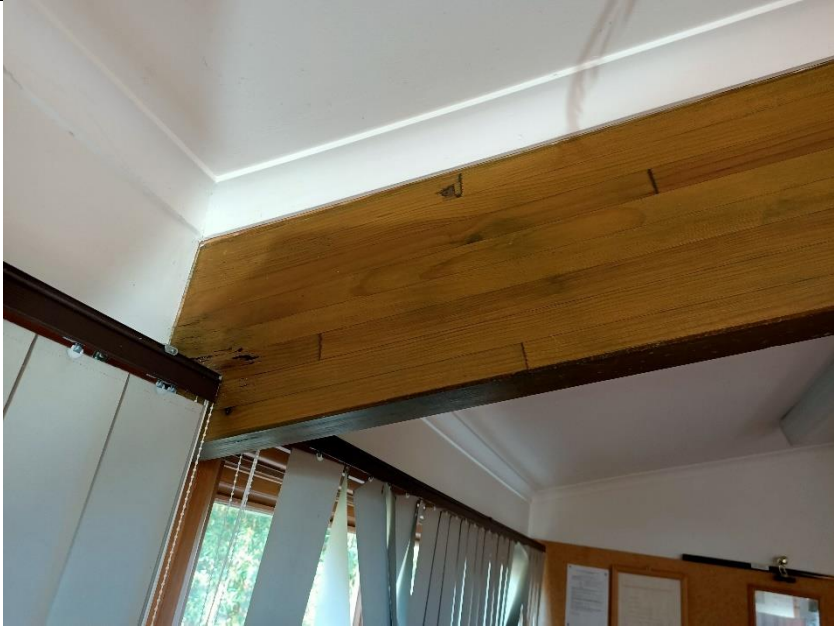
| ITEM | | ACCESS | CONDITION RATING | CONDITION DESCRIPTION | RECOMMENDED WORKS | PHOTO No. |
|---|---|---|---|---|---|---|
| 5 | Roof beams | P <sup>(1)</sup> | 3-5 | Roof beams to billiards room have extensive termite damage require removal and replacement. Roof beams elsewhere only inspected visually where possible due to restricted access. | Roof beams to billiards room require removal and replacement. Footings provided for roof beams in main hall appear unsuitable. Refer to item 9 for further discussion. Recommend replacement of footings to main hall roof beams within 6-12 months. | 23, 34 |

| Photo | Notes |
|---|---|
| | <p>Photo 23:<br/>Termite damage to roof beams in billiards room. Beams to be replaced.</p> |

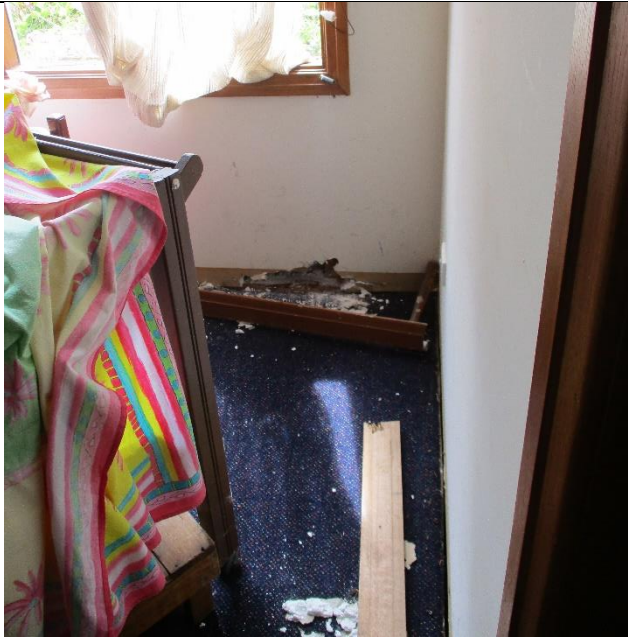
| Photo | Notes |
|---|---|
| | <p>Photo 24:<br/>Termite damage to east wall of sick bay. Wall to be replaced.</p> |

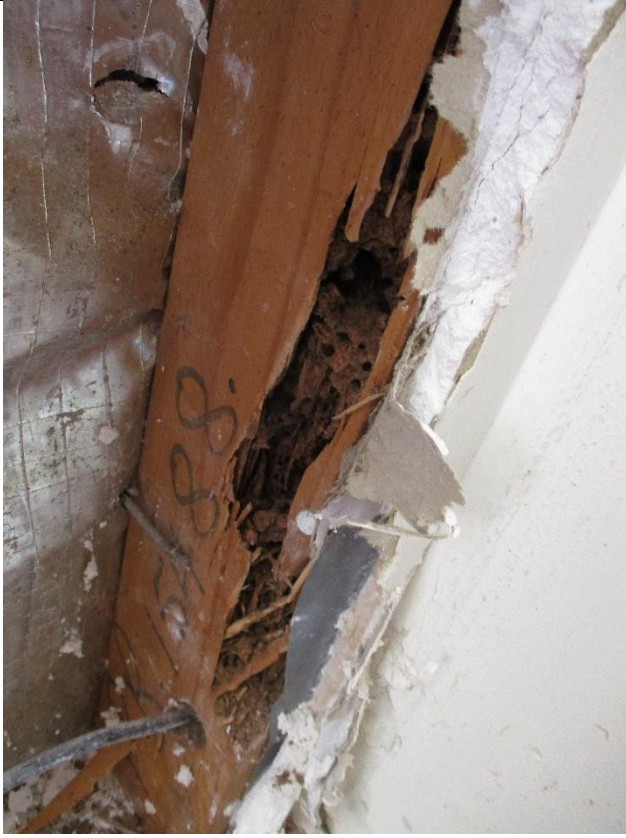
| Photo | Notes |
|---|---|
| A close-up photograph showing severe termite damage to a wooden wall. The wood is heavily decayed and crumbling, with a large section missing, revealing the internal structure. The damage is extensive, with significant loss of material and visible termite activity. | <p>Photo 25:<br/>Termite damage to east wall<br/>of sick bay.</p> |

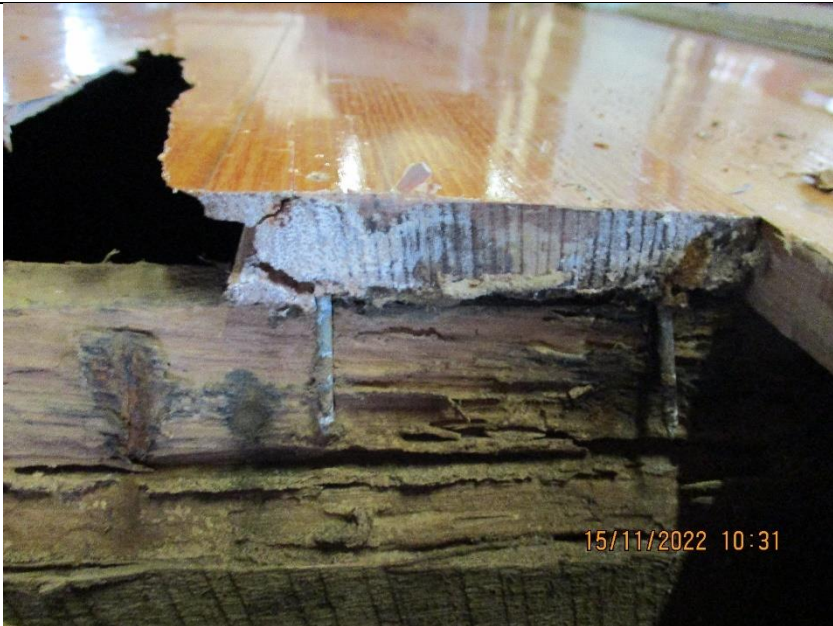
| 9 | Footings – sub-floor onto stumps | P | 3-5 | <p>As discussed in Section 4.0 and illustrated in Figure 2.0 of this report, sub-floor framing onto stumps has been assumed to the central strip consisting of the library and sick bay, main hall and south of kitchen.</p> <p>The sub-floor exposed adjacent to the library entry showed joists and bearers in very poor condition with what appears to be borer damage. The clearance to the bearers was measured at 100mm, less than the minimum required in the NCC for ventilation and significantly less than the 400mm required for termite management systems.</p> <p>The steel columns supporting the roof beams to the main hall were found to bear onto timber packers onto brick piers with the adjacent raft slab footing cast around the brick pier suggesting the areas with raft slab footings were installed as later additions to the main hall.</p> <p>The plate at the base of the steel column inspected was corroded likely due to the high moisture build up in the sub floor due to lack of ventilation.</p> <p>The sub floor to the main hall does not have sufficient ventilation, there is no cross flow from north to south due to the concrete raft slabs each side of the sub-floor area, the ventilation to the east is hindered by planting and to the west is hindered by the access deck.</p> <p>The timber access deck to the west wall has insufficient clearance to the ground, does not appear to be drained and is obstructing ventilation to the sub-floor.</p> | <p>The works required to rectify the sub-floor is extensive and would include as a minimum:</p> <ul style="list-style-type: none"> <li>- expose the existing sub-floor elements to allow an inspection of each and every element,</li> <li>- replace the framing elements that are damaged or degraded,</li> <li>- provide minimum clearance to all sub-floor framing members suitable for a termite management system i.e. 400mm,</li> <li>- investigate the need for forced ventilation to account for the loss of cross flow in the north south direction,</li> <li>- investigate the remaining footings to the main hall steel columns and posts and carry out remedial works as required including provision of a new pad footing for the column identified in photo 34,</li> <li>- clear garden beds away from the east wall clearing any obstruction to sub-floor ventilation ducts,</li> <li>- remove timber access deck to the west wall and reinstate to ensure free ventilation to the sub-floor, minimum clearances to the timber framing and adequate drainage below the deck.</li> </ul> <p>The extent of remedial works required to repair the sub-floor is such that a new raft slab footing is recommended to replace all existing sub-floor framing. A raft slab would not require sub-floor ventilation, external paved areas could be cast up to 50mm below the slab level and the main hall columns and posts could be founded directly onto the raft slab. The slab would act as a barrier to minimise the risk of ongoing termite infestation to any above ground timber elements. All load bearing elements including columns, posts and internal load bearing walls would need to be propped to allow installation of a raft slab. Access to main hall should be prevented until rectification works are completed.</p> | 26, 27, 28, 29, 30, 31, 32, 33, 34, 35, 36, 37, 38 |

| Photo | Notes |
|---|---|
| A photograph showing rot and borer damage to a sub-floor. The wood is dark, wet, and heavily decayed, with a large section missing. The damage is extensive, with significant loss of material and visible termite activity. A timestamp '15/11/2022 10:31' is visible in the bottom right corner of the photo. | <p>Photo 26:<br/>Rot and borer damage to sub-<br/>floor of main hall adjacent to<br/>library entrance.</p> |

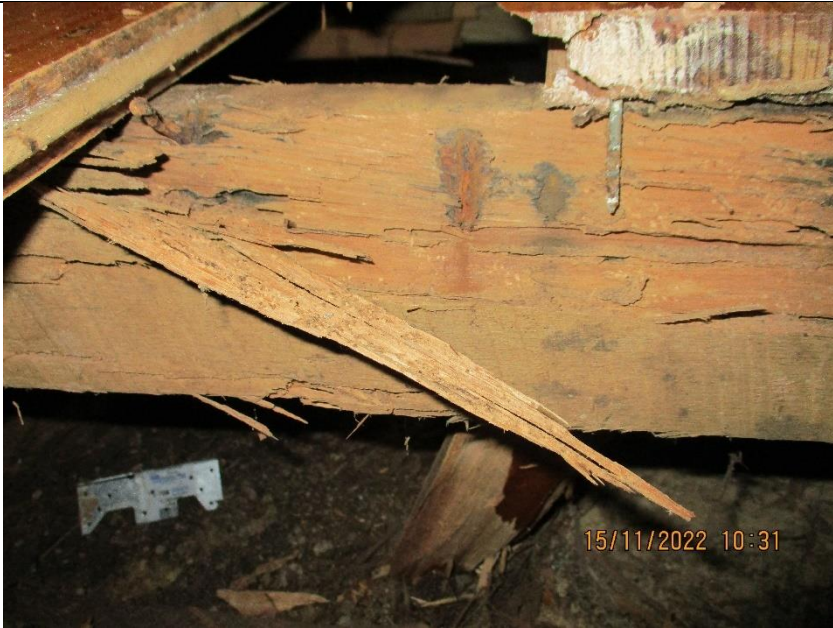
| Photo | Notes |
|---|---|
| A photograph showing severe rot and borer damage to a wooden sub-floor. The wood is heavily decayed, with a large section missing, revealing a dark, hollowed-out interior. A metal fastener is visible in the remaining wood. A timestamp "15/11/2022 10:31" is visible in the bottom right corner. | <p>Photo 27:<br/>Rot and borer damage to sub-floor of main hall adjacent to library entrance.</p> |

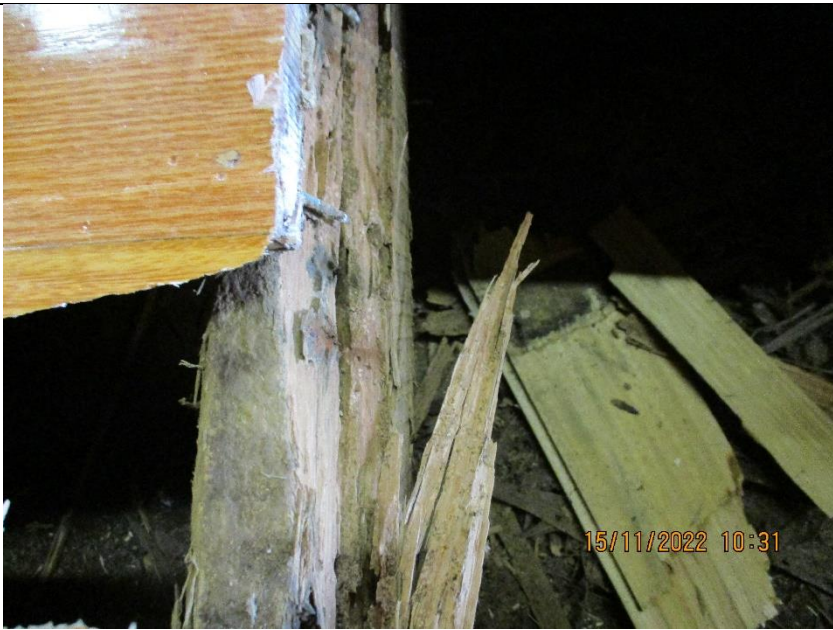
| Photo | Notes |
|---|---|
| A photograph showing rot and borer damage to a wooden sub-floor. The wood is heavily decayed, with a large section missing, revealing a dark, hollowed-out interior. A metal fastener is visible in the remaining wood. A timestamp "15/11/2022 10:31" is visible in the bottom right corner. | <p>Photo 28:<br/>Rot and borer damage to sub-floor of main hall adjacent to library entrance.</p> |

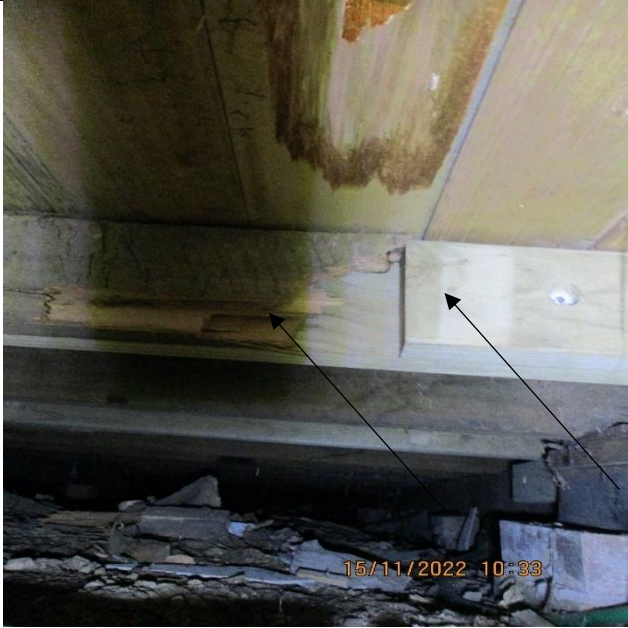
| Photo | Notes |
|---|---|
| <p>15/11/2022 10:33</p> | <p>Photo 29:<br/>Evidence of historic rot and borer damage to sub-floor of main hall adjacent to library entrance with historic local repairs.</p> |

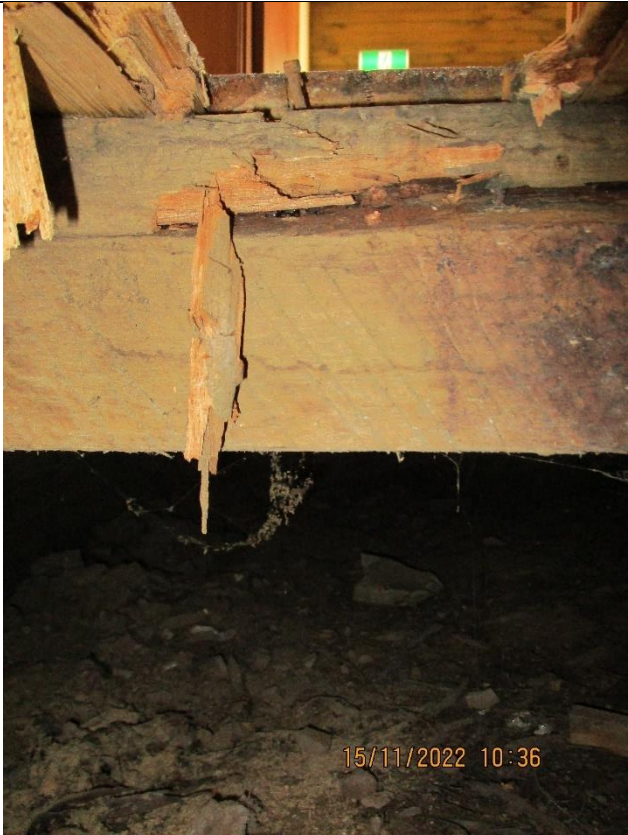
| Photo | Notes |
|---|---|
| <p>15/11/2022 10:36</p> | <p>Photo 30:<br/>Rot and borer damage to sub-floor of main hall adjacent to library entrance.</p> |

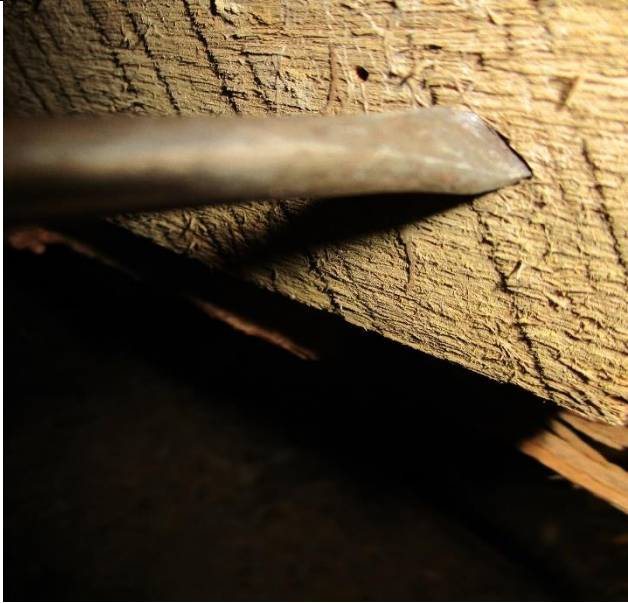
| Photo | Notes |
|---|---|
| | <p>Photo 31:<br/>Screwdriver pushed into face of joist in sub-floor area adjacent to library entrance indicating degradation.</p> |

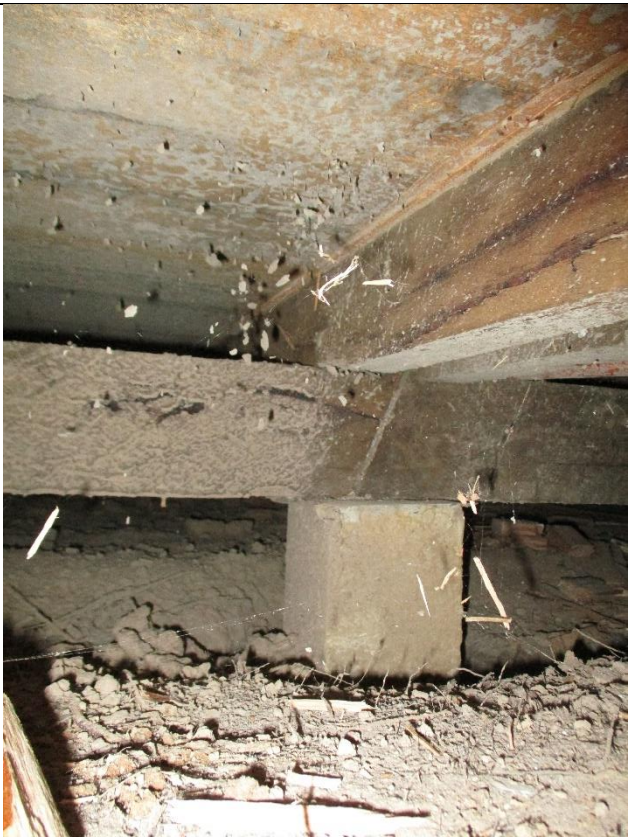
| Photo | Notes |
|---|---|
| | <p>Photo 32:<br/>General photo of clearance to sub-floor in main hall less than 150mm minimum required under the NCC and significantly less than the 400mm required for termite management systems.</p> |
