# Structural Inspection Report

Client: **Surf Coast Shire Council**

Site Address: **Anglesea and Aireys Inlet  
Senior Citizens Club,  
1 McMillan Street, Anglesea**

Inspection By: **Niall Logue**  
Report Date: **28<sup>th</sup> November 2022**  
Inspection Date: **15<sup>th</sup> November 2022**  
ACA Project Ref No. **22-185**  
Report No: **Rep-02**

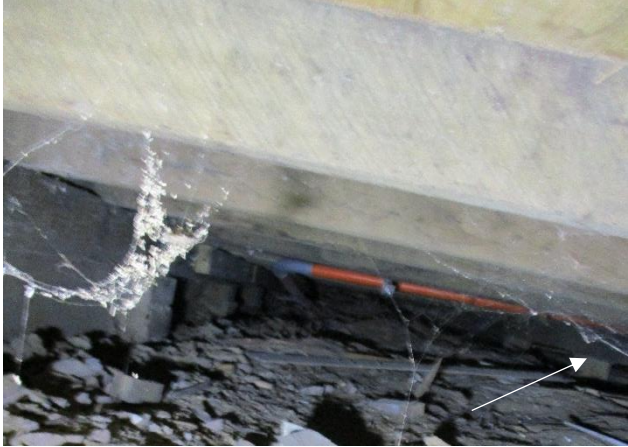
| 9 | Footings – sub-floor onto stumps | P | 3-5 | <p>As discussed in Section 4.0 and illustrated in Figure 2.0 of this report, sub-floor framing onto stumps has been assumed to the central strip consisting of the library and sick bay, main hall and south of kitchen.</p> <p>The sub-floor exposed adjacent to the library entry showed joists and bearers in very poor condition with what appears to be borer damage. The clearance to the bearers was measured at 100mm, less than the minimum required in the NCC for ventilation and significantly less than the 400mm required for termite management systems.</p> <p>The steel columns supporting the roof beams to the main hall were found to bear onto timber packers onto brick piers with the adjacent raft slab footing cast around the brick pier suggesting the areas with raft slab footings were installed as later additions to the main hall.</p> <p>The plate at the base of the steel column inspected was corroded likely due to the high moisture build up in the sub floor due to lack of ventilation.</p> <p>The sub floor to the main hall does not have sufficient ventilation, there is no cross flow from north to south due to the concrete raft slabs each side of the sub-floor area, the ventilation to the east is hindered by planting and to the west is hindered by the access deck.</p> <p>The timber access deck to the west wall has insufficient clearance to the ground, does not appear to be drained and is obstructing ventilation to the sub-floor.</p> | <p>The works required to rectify the sub-floor is extensive and would include as a minimum:</p> <ul style="list-style-type: none"> <li>- expose the existing sub-floor elements to allow an inspection of each and every element,</li> <li>- replace the framing elements that are damaged or degraded,</li> <li>- provide minimum clearance to all sub-floor framing members suitable for a termite management system i.e. 400mm,</li> <li>- investigate the need for forced ventilation to account for the loss of cross flow in the north south direction,</li> <li>- investigate the remaining footings to the main hall steel columns and posts and carry out remedial works as required including provision of a new pad footing for the column identified in photo 34,</li> <li>- clear garden beds away from the east wall clearing any obstruction to sub-floor ventilation ducts,</li> <li>- remove timber access deck to the west wall and reinstate to ensure free ventilation to the sub-floor, minimum clearances to the timber framing and adequate drainage below the deck.</li> </ul> <p>The extent of remedial works required to repair the sub-floor is such that a new raft slab footing is recommended to replace all existing sub-floor framing. A raft slab would not require sub-floor ventilation, external paved areas could be cast up to 50mm below the slab level and the main hall columns and posts could be founded directly onto the raft slab. The slab would act as a barrier to minimise the risk of ongoing termite infestation to any above ground timber elements. All load bearing elements including columns, posts and internal load bearing walls would need to be propped to allow installation of a raft slab. Access to main hall should be prevented until rectification works are completed.</p> | 26, 27, 28, 29, 30, 31, 32, 33, 34, 35, 36, 37, 38 |

| Photo | Notes |
|---|---|
| | <p>Photo 33:</p> <p>General photo of clearance to sub-floor in main hall less than 150mm minimum required under the NCC and significantly less than the 400mm required for termite management systems.</p> |

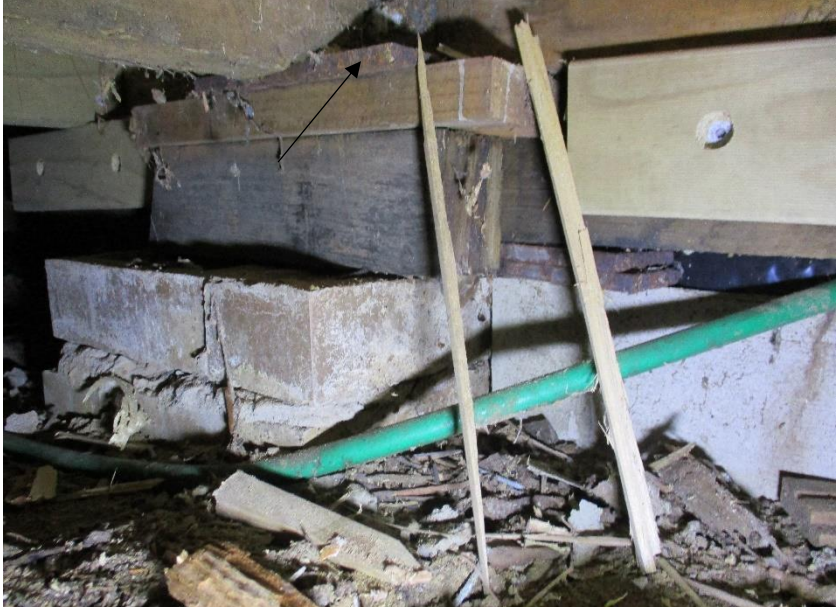
| ITEM | | ACCESS | CONDITION RATING | CONDITION DESCRIPTION | RECOMMENDED WORKS | PHOTO No. |
|---|---|---|---|---|---|---|
| 5 | Roof beams | P <sup>(1)</sup> | 3-5 | Roof beams to billiards room have extensive termite damage require removal and replacement. Roof beams elsewhere only inspected visually where possible due to restricted access. | Roof beams to billiards room require removal and replacement. Footings provided for roof beams in main hall appear unsuitable. Refer to item 9 for further discussion. Recommend replacement of footings to main hall roof beams within 6-12 months. | 23, 34 |

| Photo | Notes |
|---|---|
| | <p>Photo 34:</p> <p>Corroded baseplate to steel column supporting main hall roof beam onto timber packing over brick pier with face of adjacent raft slab visible to right.</p> |

The existing footings to the main hall roof beams requires investigation and any that are not founded directly onto concrete pad footings or concrete raft slab footings are to be replaced. This would require propping of all structural posts, columns and load bearing walls to the main hall.

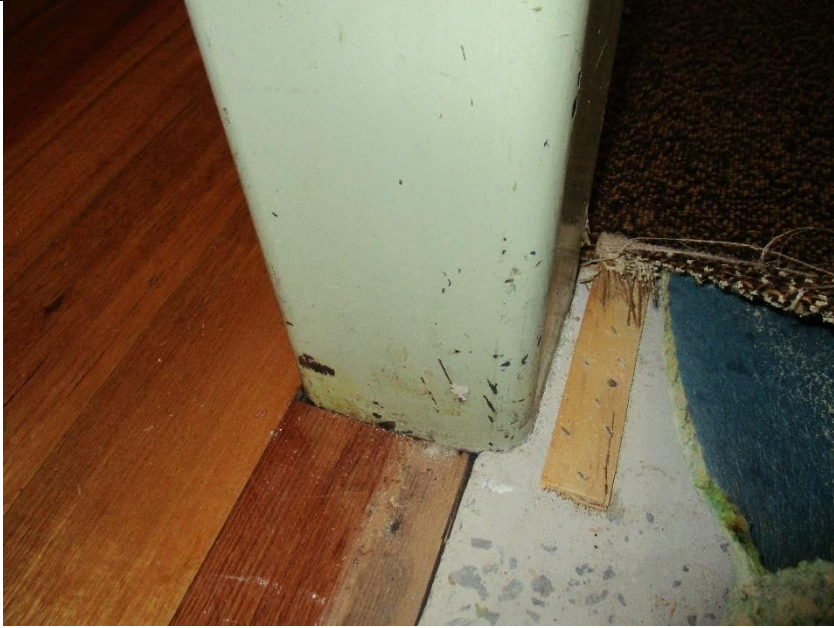
| Photo | Notes |
|---|---|
| | <p>Photo 35:</p> <p>Photo of column in photo 34 from above floor level with raft slab cast against face of steel column.</p> |

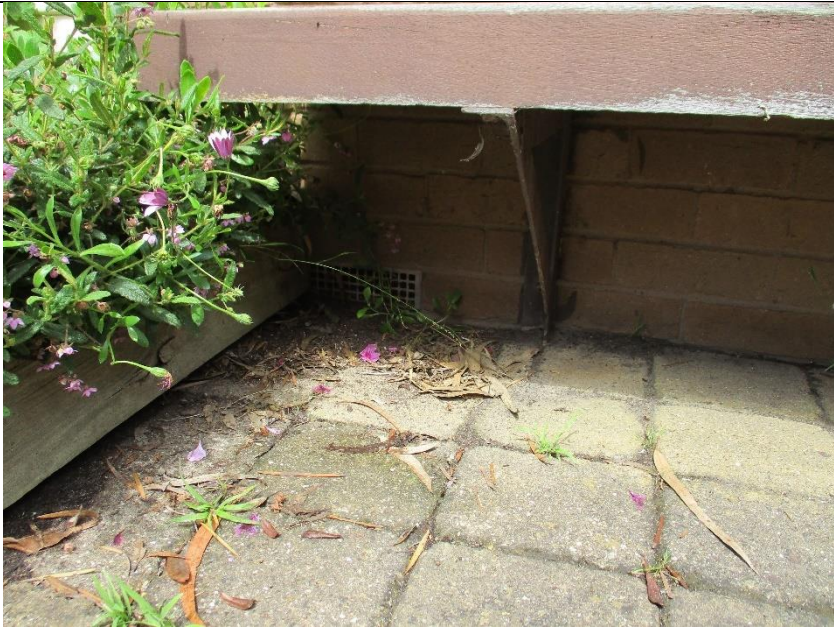
| Photo | Notes |
|---|---|
| | <p>Photo 36:</p> <p>Planting built up over sub-floor ventilation to east of sick bay and north of billiards room.</p> |

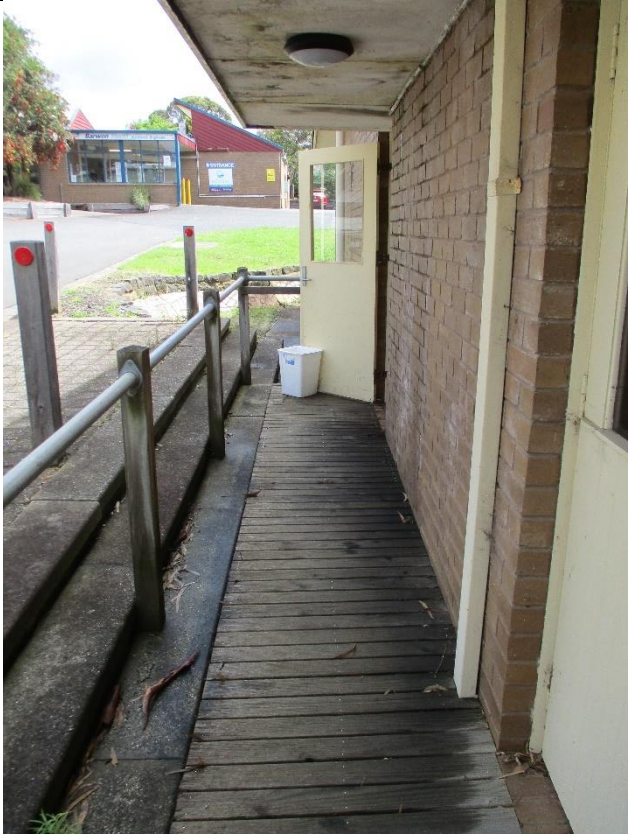
| ITEM | | ACCESS | CONDITION RATING | CONDITION DESCRIPTION | RECOMMENDED WORKS | PHOTO No. |
|---|---|---|---|---|---|---|
| 10 | Site maintenance | R | 4-5 | <p>Site drainage is in poor to very poor condition. The ground around the perimeter of the building is not adequately drained. The ground does not grade away a minimum 50mm over 1000mm to ensure no ponding at the footings. The ground is not drained to collect all surface water and drain to the LPOD.</p> <p>There are no pits provided to the north wall at the base of the retaining wall. Insufficient pits have been provided to the west wall. No drainage pits appear to have been provided below the access deck.</p> <p>The existing pit to the north wall is completely blocked. Pits have not been provided below external taps. There does not appear to be any pits provided along the east or south walls. Rainwater pipes were noted to discharge direct to ground and were not connected to the below ground drainage system to the east of the east wall in the billiards room in the area of most severe termite damage.</p> | <p>Garden beds should be removed away from the building ensuring all external ground levels are minimum 150mm below the internal floor slab level, or minimum 50mm below internal slab levels where a concrete pavement has been provided externally, or below any sub-floor ventilation ducts.</p> <p>The ground around the perimeter should be graded to ensure a minimum fall of 50mm away from the footings over a 1000mm distance suitable drained and collected to ensure all surface water run off is drained to the LPOD.</p> <p>This should result in pits at approximately 8m spacing around the building and at closer spacing where conditions require to ensure no ponding.</p> <p>Consideration to be given to the installation of concrete pavement around full building perimeter to falls noted above to minimise risk of ongoing movement.</p> <p>CCTV survey and pressure tests of all below ground drainage should be carried out to check for leaks with repairs carried out as required. Refer to Appendix C for suggested procedures.</p> <p>All downpipes to be positively connected to below ground drainage system and ultimately to the LPOD.</p> | 37, 38, 39, 40, 41, 42, 43, 44 |

| Photo | Notes |
|---|---|
| | <p>Photo 37:<br/>Timber access deck to west wall obstructing sub-floor ventilation. No drainage to sub-floor visible. Insufficient clearance to sub-floor framing.</p> |

The canopy to the west wall, fascia boards, timber cladding to the west wall and east wall of the sick bay and access deck to the west wall are recommended to be replaced.

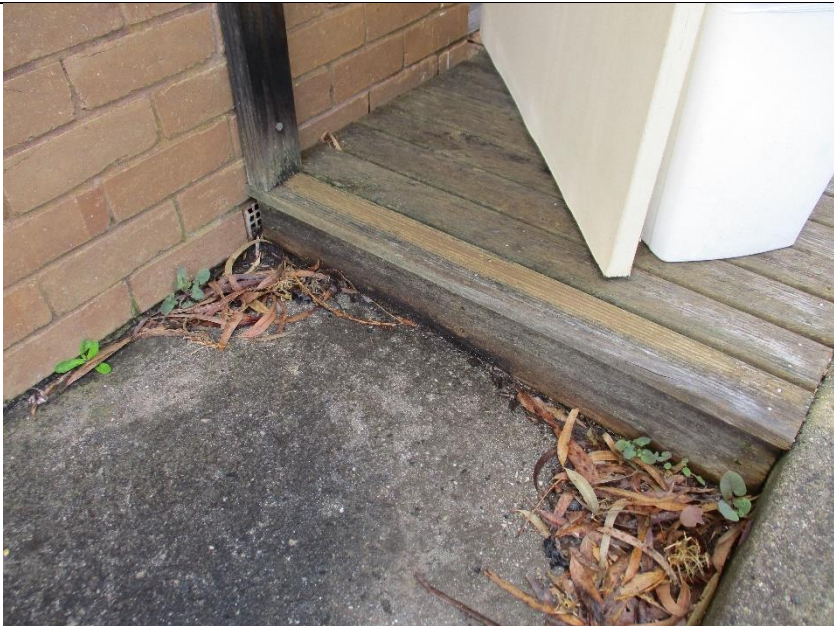
| Photo | Notes |
|---|---|
| | <p>Photo 38:<br/>Sub-floor framing to access deck to west wall obstructing sub-floor ventilation. No drainage to sub-floor visible. Insufficient clearance to sub-floor framing.</p> |

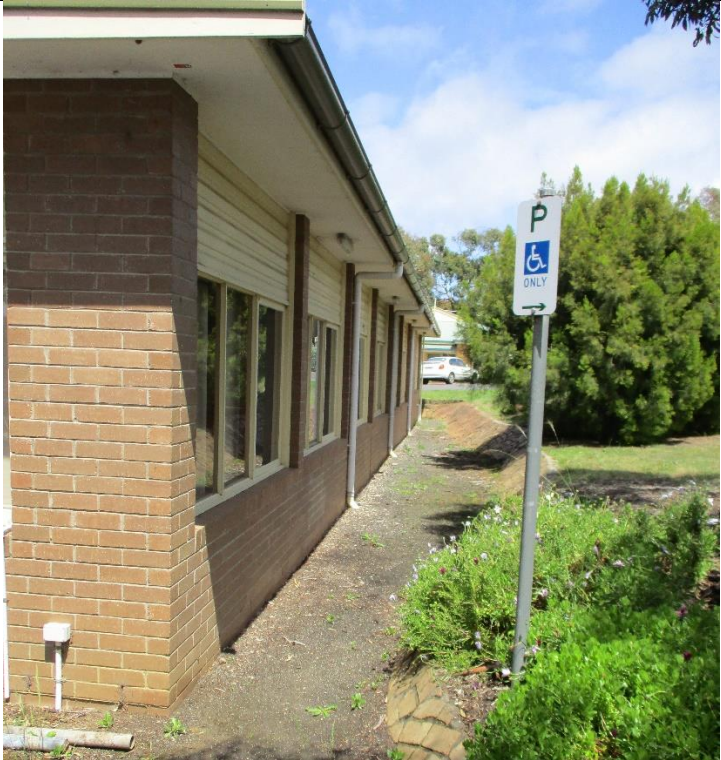
| Photo | Notes |
|---|---|
| A side view of a brick building with a parking sign. The building has a brick base and a light-colored upper section. A parking sign with a 'P' and a wheelchair symbol is visible. The ground is covered with gravel and some greenery. | <p>Photo 39:<br/>No drainage pits visible to north wall at base of retaining wall.</p> |

The site drainage works are in very poor condition and require substantial works to rectify the issues identified.

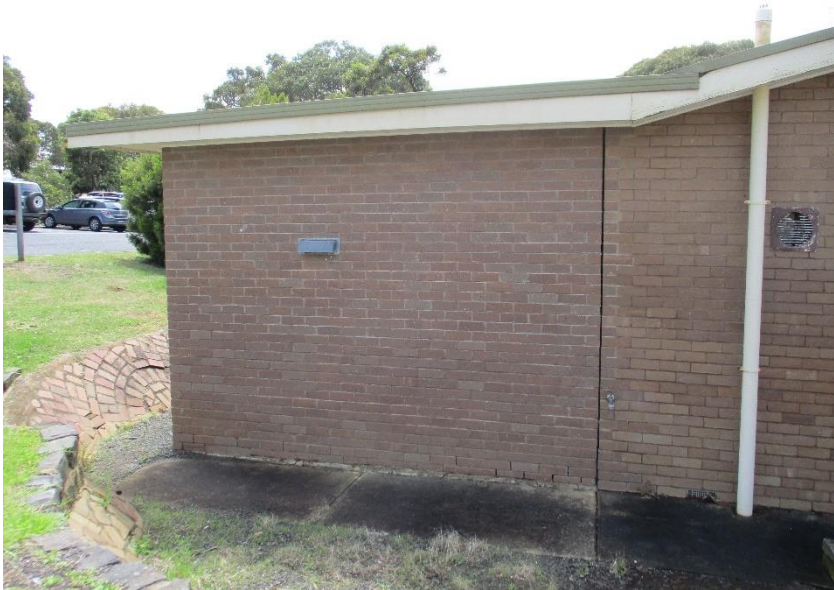
| Photo | Notes |
|---|---|
| A view of a brick wall with a drainage pipe. The wall is made of brick and has a white downspout. The ground in front of the wall is covered with grass and some gravel. | <p>Photo 40:<br/>Insufficient drainage provision to west wall.</p> |

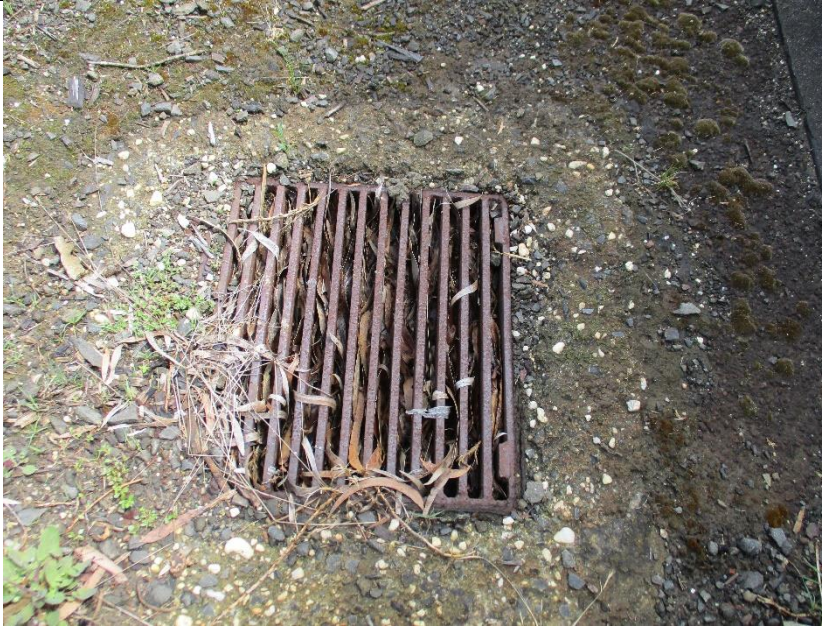
| Photo | Notes |
|---|---|
| | <p>Photo 41:<br/>Existing pit to west wall<br/>fully blocked.</p> |

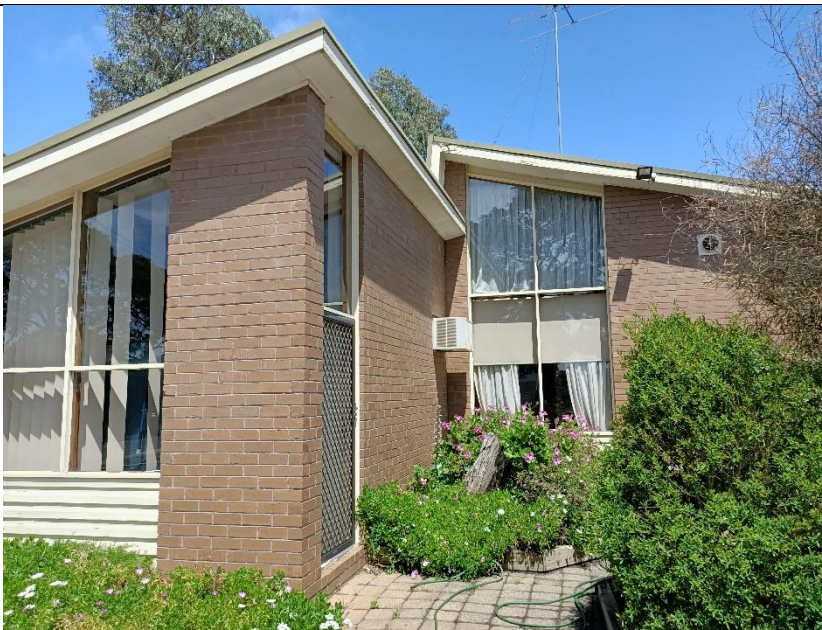
| Photo | Notes |
|---|---|
| | <p>Photo 42:<br/>No drainage pits visible to<br/>east wall. Planting above<br/>internal floor levels and<br/>against timber cladding<br/>obscuring sub-floor<br/>ventilation. Ground not<br/>graded away from footings.</p> |

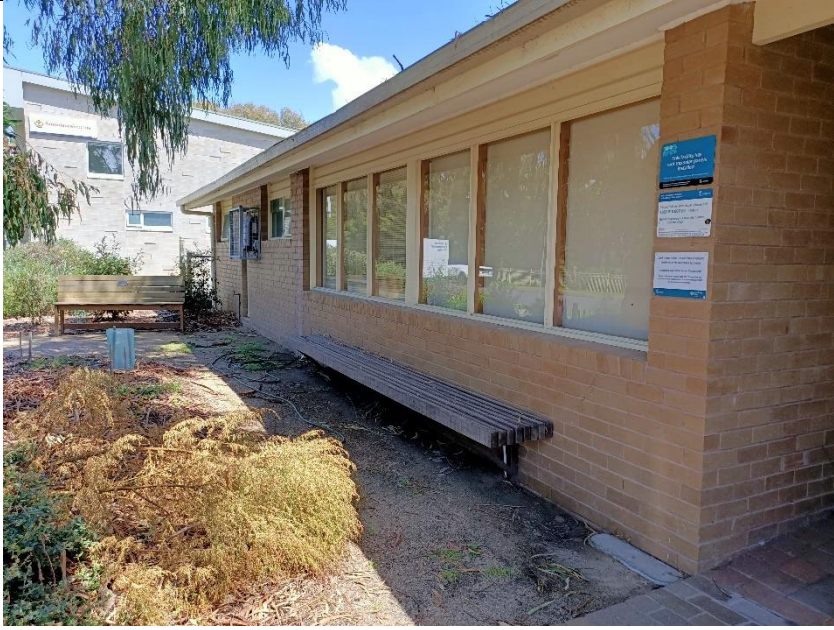
| Photo | Notes |
|---|---|
| | <p>Photo 43:</p> <p>No drainage pits visible to south wall. Ground not graded away from footings. No pits under external taps.</p> |

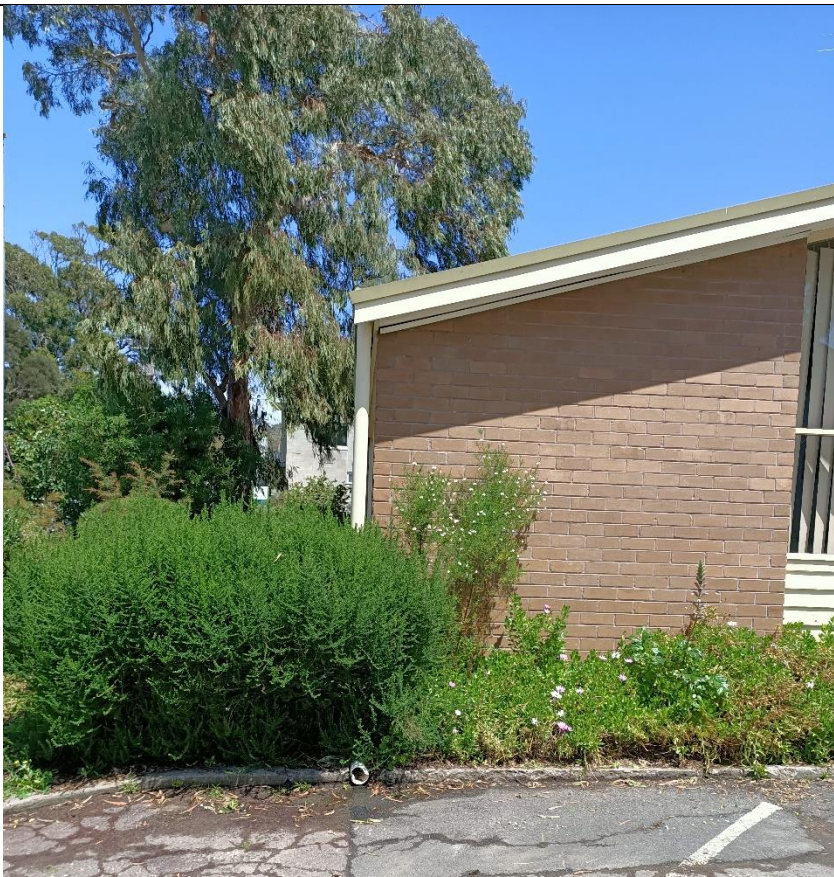
| Photo | Notes |
|---|---|
| | <p>Photo 44:</p> <p>Rainwater pipe discharging directly onto broken bitumen pavement to adjacent car park to east wall resulting in high moisture levels of ground adjacent to most severe area of termite damage.</p> |
