Site Analysis

4.1 OVERVIEW

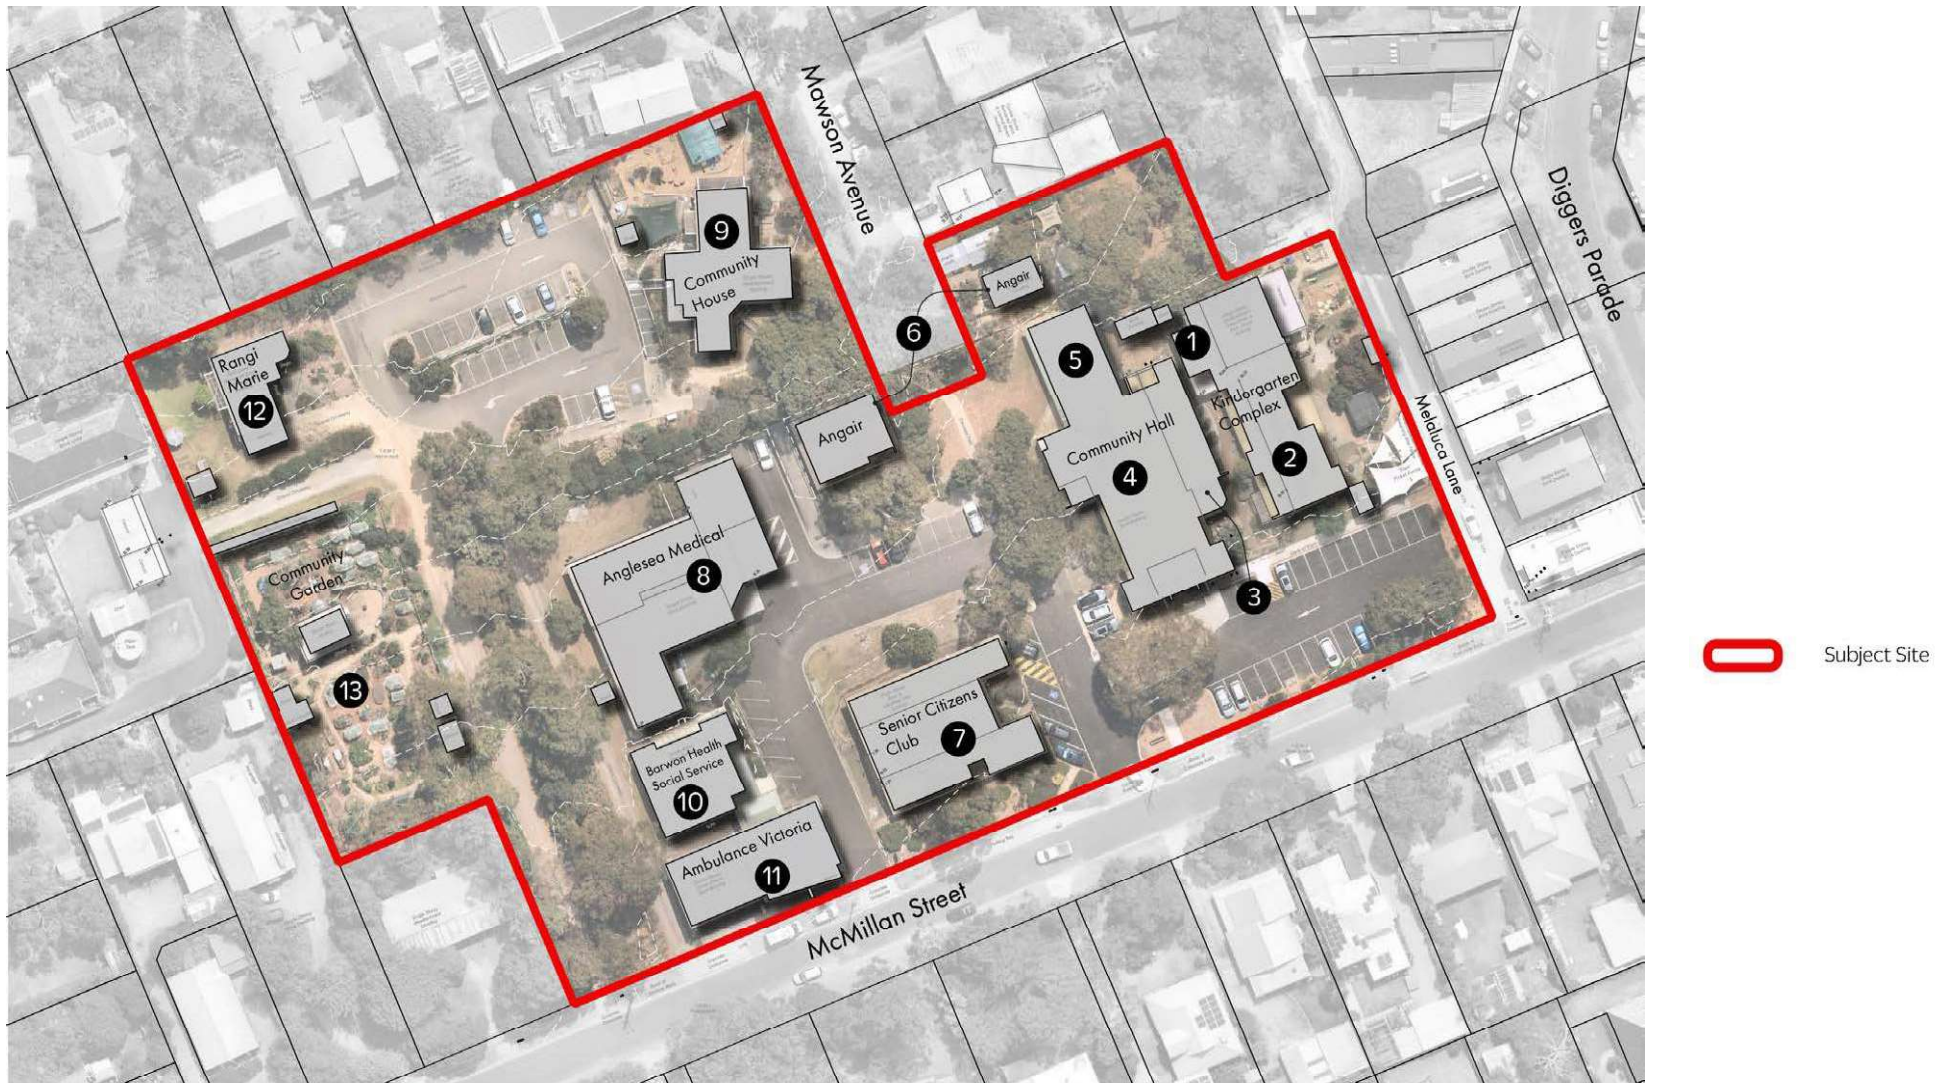
Figure 13. Existing uses

Figure 10 Maps the following existing uses across the Site:

1. Anglesea Maternal Health
2. Anglesea Kindergarten
3. Anglesea Toy Library
4. Anglesea Memorial Community Hall
5. Youth Room
6. Angair (Anglesea, Aireys Inlet Society for the Preservation of Flora and Fauna)
7. Anglesea Senior Citizens Club Room (currently defunct and in disuse)
8. Anglesea Medical Centre
9. Anglesea Community Hall
10. Barwon Health Social Support Service
11. Ambulance Victoria
12. Anglesea Historical Society - 'Rangi Marie'
13. Anglesea Community Garden

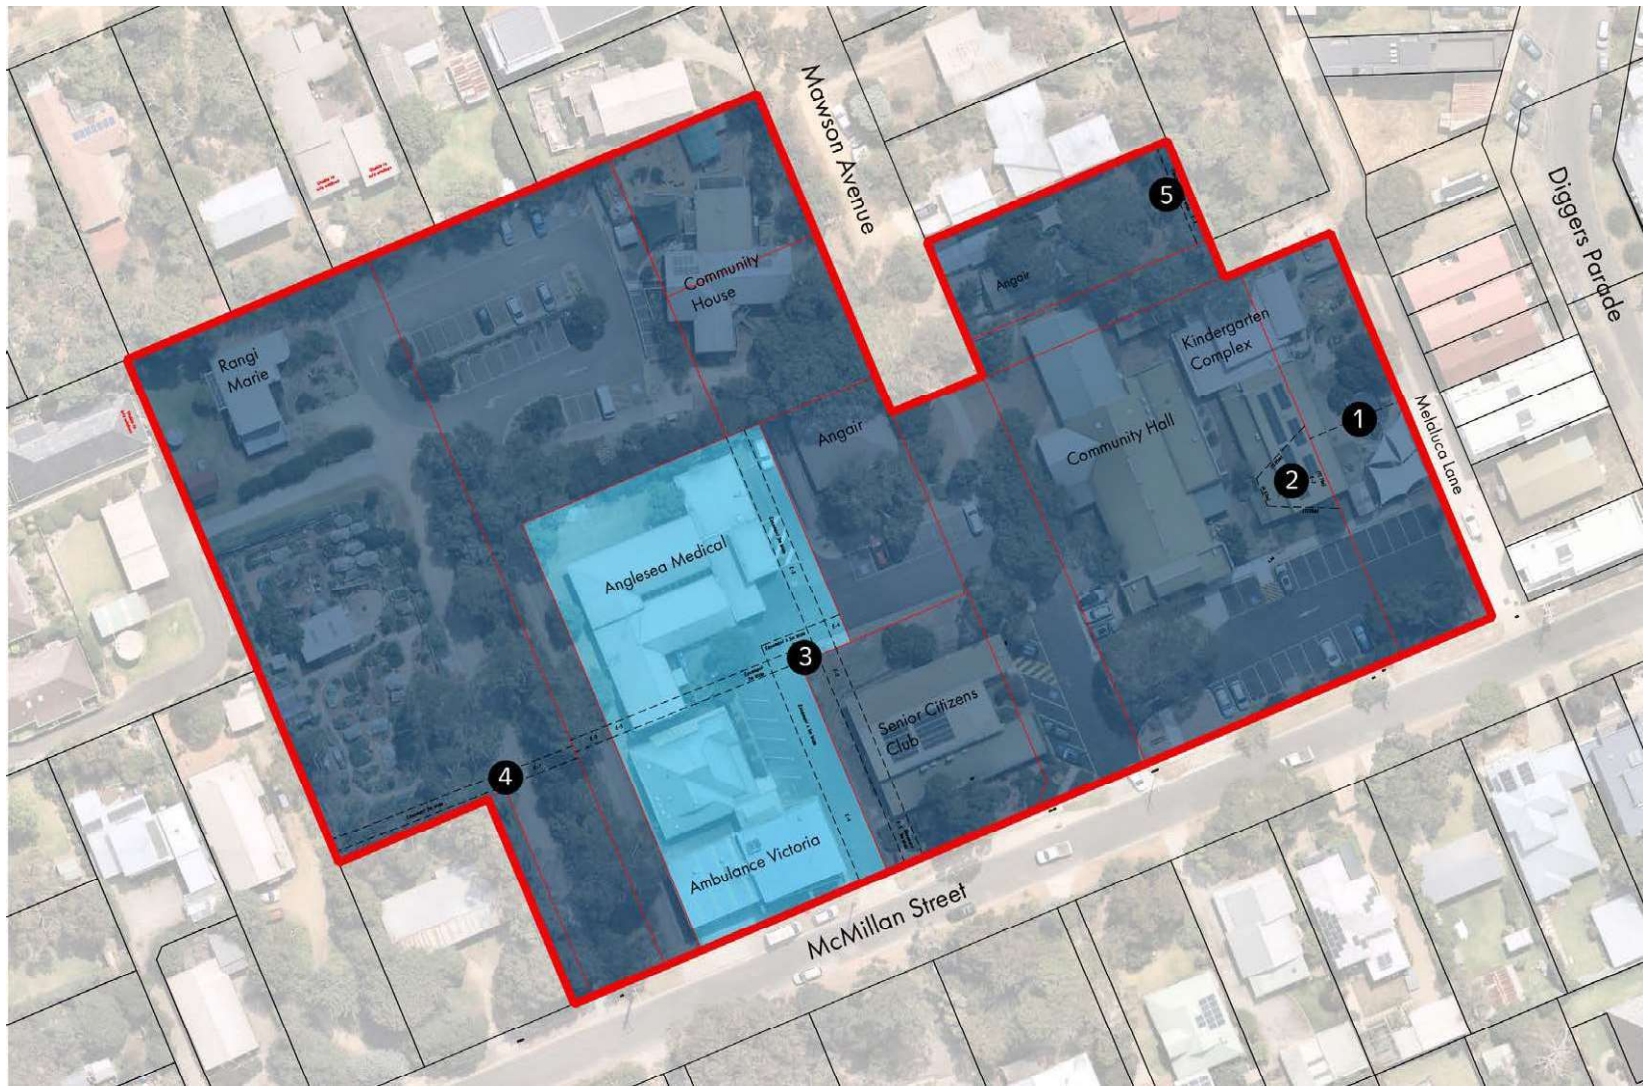
Figure 16. Site ownership, showing easements and encumbrances

No.	Address	Title	Encumbrance	Ownership
1	1 McMillan Street	Lot 1 Title Plan 342965K	Right of carriageway (i.e. movement)	Surf Coast Council
2		Lot 1 Title Plan 342965K (shown in yellow on Title) & Lot 1 on Title Plan 519511T (shown in blue on Title)	Drainage and sewage for the allotment at 1a McMillan Street only (not for the Drainage Authority)	Surf Coast Council
3	3 McMillan Street	Lot 3 Subdivision Plan 610286C (E1 & E3)	Carriageway easements (4.5m wide) in favour of Lots 2&3	Barwon Health
		Lot 3 Subdivision Plan 610286C (E2 & E3)	Sewerage easement for Barwon Water	Barwon Health
4	5 McMillan Street	Lot 1 Subdivision Plan 329493P	Sewerage easement for Barwon Water (2m wide)	Surf Coast Council
5	2 Mawson Avenue	Lot 1 Subdivision Plan 86764	Suspected drainage easement	Surf Coast Council

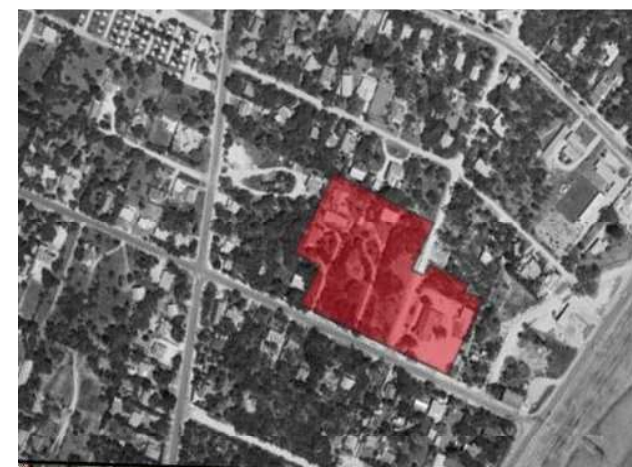
1970 aerial photo of the Site, showing Mawson Avenue extending through to McMillan Street

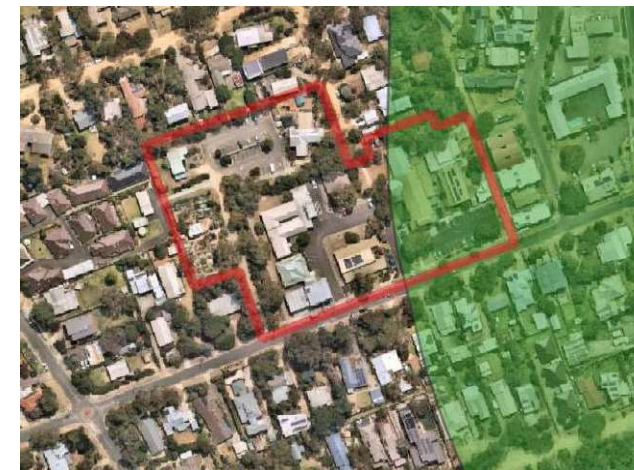
Figure 17. Extent of Area of Aboriginal cultural sensitivity

The eastern part of the Site, including Anglesea Community Hall, Anglesea Kindergarten and the adjacent car parking is less than 200m from Kuarka-dorla (Anglesea River).

In the inverse it can be determined, at the desktop level that the area has been subject to significant ground disturbance and therefore, the *Regulations* actually consider the area no longer of cultural sensitivity.

However, without prior archaeological and geotechnical investigations that can determine level of soil disturbance, it is difficult to determine the precise likelihood of Aboriginal cultural heritage within the Site. Therefore, a Cultural Heritage Management Plan will be required unless significant ground disturbance can be confirmed.

Prior to the preparation of a Cultural Heritage Management Plan a Preliminary Aboriginal Heritage Test (PAHT) could be prepared. A PAHT would be used to formally determine whether proposed activities require the preparation of a Cultural Heritage Management Plan, and particularly to determine whether significant ground disturbance has extinguished the area's cultural heritage sensitivity.

- Engage early and meaningfully with WTOAC
- Determine whether significant site ground disturbance has occurred on the Site as a means to establishing the need for a Cultural Heritage Management Plan.
- Consider a staged approach wherein works are separated between areas of Cultural Heritage Sensitivity and non-Cultural Heritage Sensitivity. All works outside areas identified as sensitive will not require a mandatory Cultural Heritage Management Plan regardless of significant ground disturbance.
- Consider undertaking a voluntary Cultural Heritage Management Plan if determined that a mandatory Cultural Heritage Management Plan is not required.
- Focus new works within already disturbed areas.

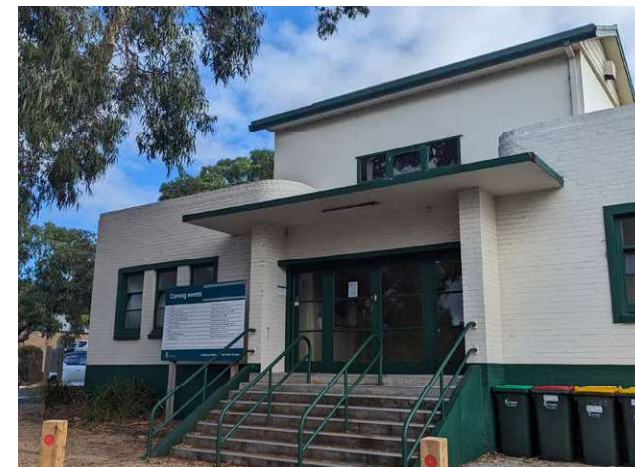
Two structures on the Site - the Anglesea Memorial Hall and Rangi Marie (Anglesea Historical Society), were built in 1954 in the inter-war Functionalist style and are included in the Surf Coast Heritage Overlay. The remainder of buildings have no heritage value.

Anglesea Memorial Hall and Rangi Marie buildings are in reasonable condition for their age but will require repair and conservation works.

On-going maintenance for the built fabric of the Anglesea Memorial Hall and Rangi Marie will be necessary to conserve the significant built fabric. Timely maintenance and repair, based on regular inspection and technically sound and appropriate construction methods, are essential for the conservation of historic fabric.

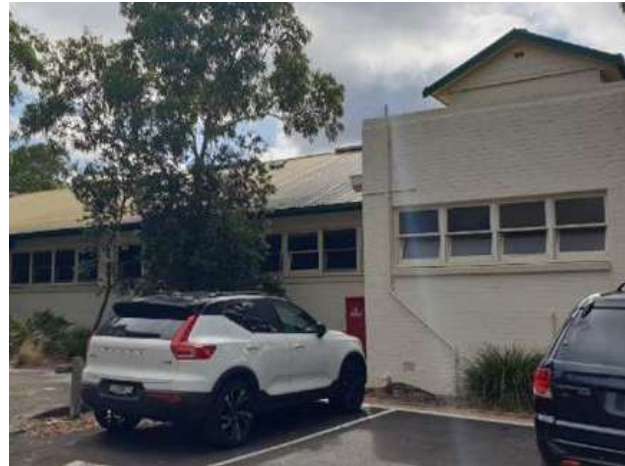
West elevation with protruding bay with the green corrugated sheet metal roof is a later addition (c1990s).

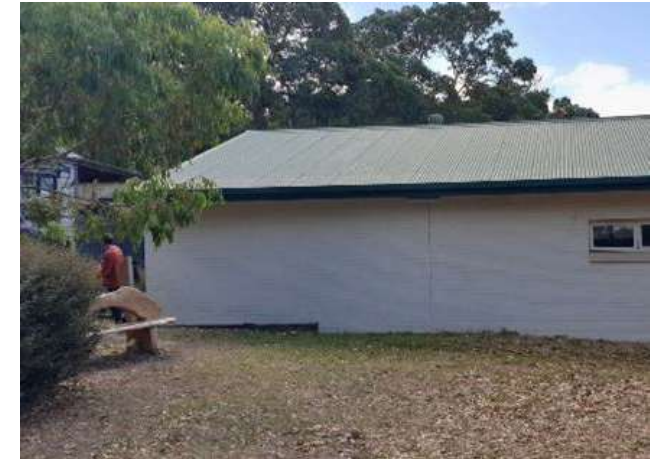
Rear gable roofed addition

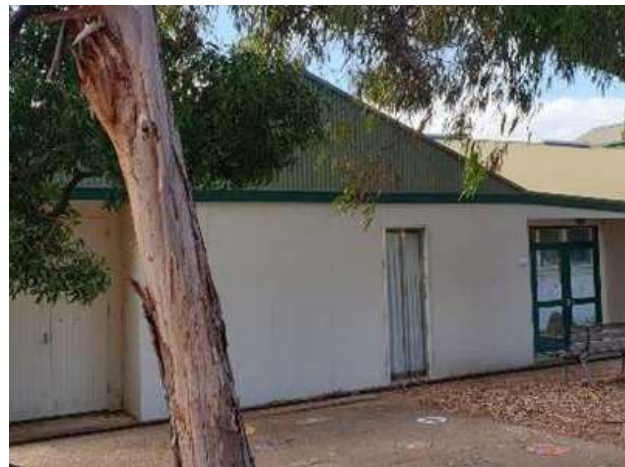
The Hall and its western addition looking southeast

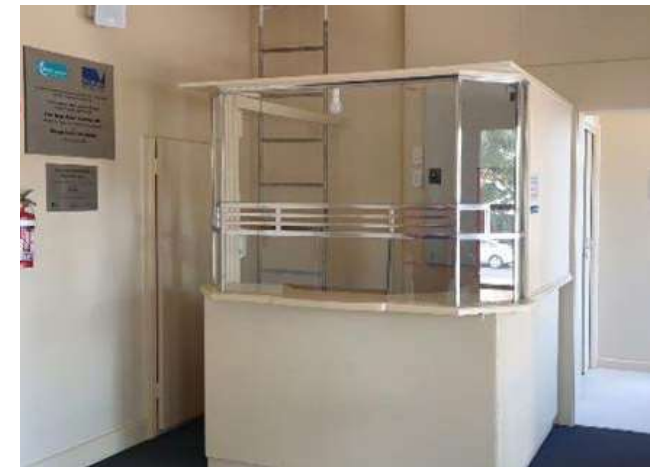
Interior of entry foyer showing ticket booth and ladder to upper room.

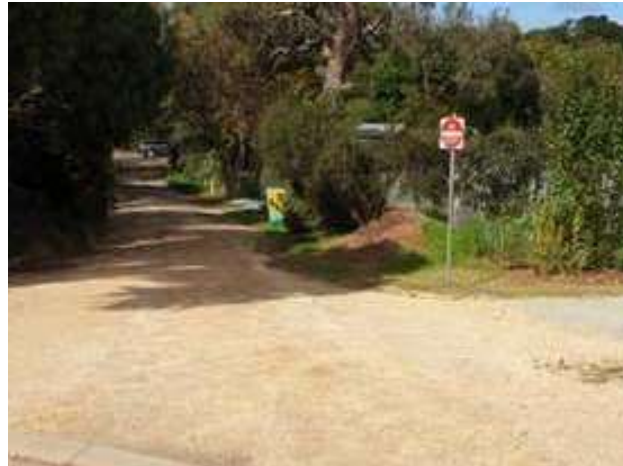
Gravel drive (looking south) connecting to McMillan Street. This appears in early photos and is part of the original battle axe title for the block.

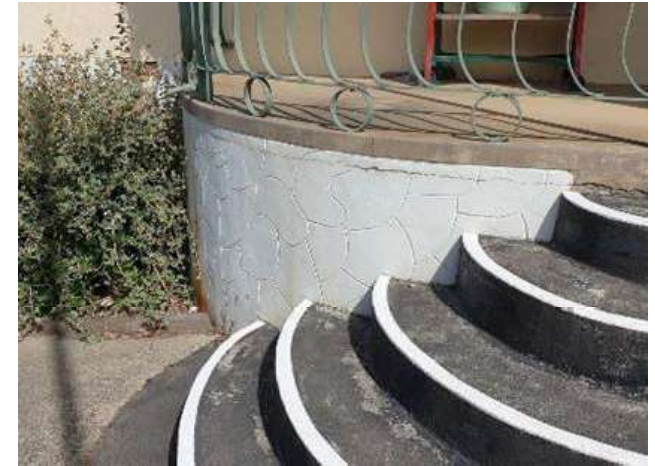
Front steps and porch, note ruled patterning to simulate crazy paving stonework.

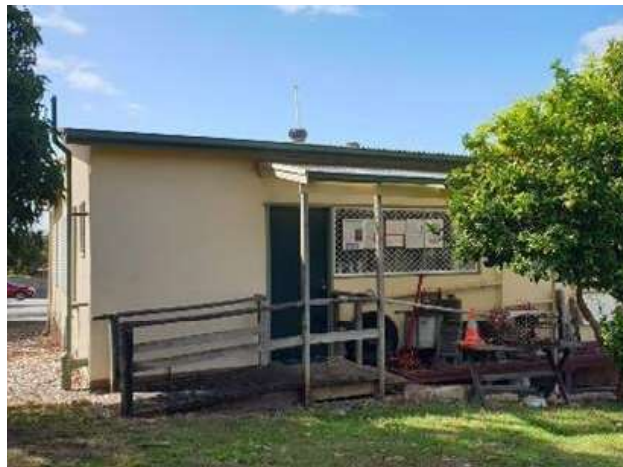
Rear elevation showing utilitarian nature of detailing.

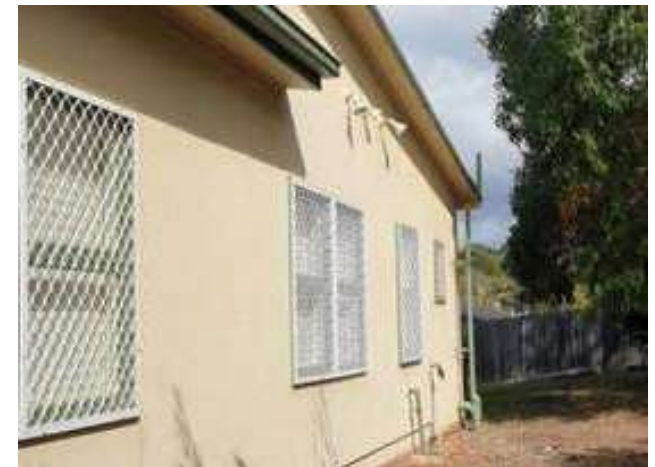
North elevation showing junction between main skillion roof and flat roof section

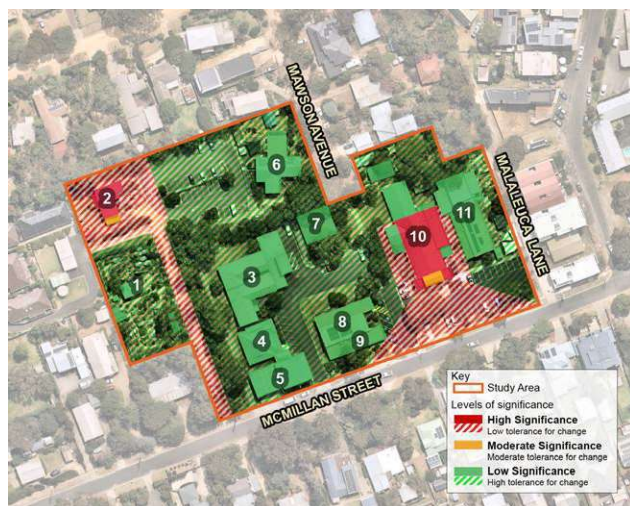
Figure 18. Plan highlighting the levels of relative heritage significance on the Site.

The Site can be broken down into three categories of tolerance for change - low, moderate or high. These are determined by the level of historic or heritage significance

The rear of the Hall and the later additions such as the western gable roofed entry are considered as low heritage significance.

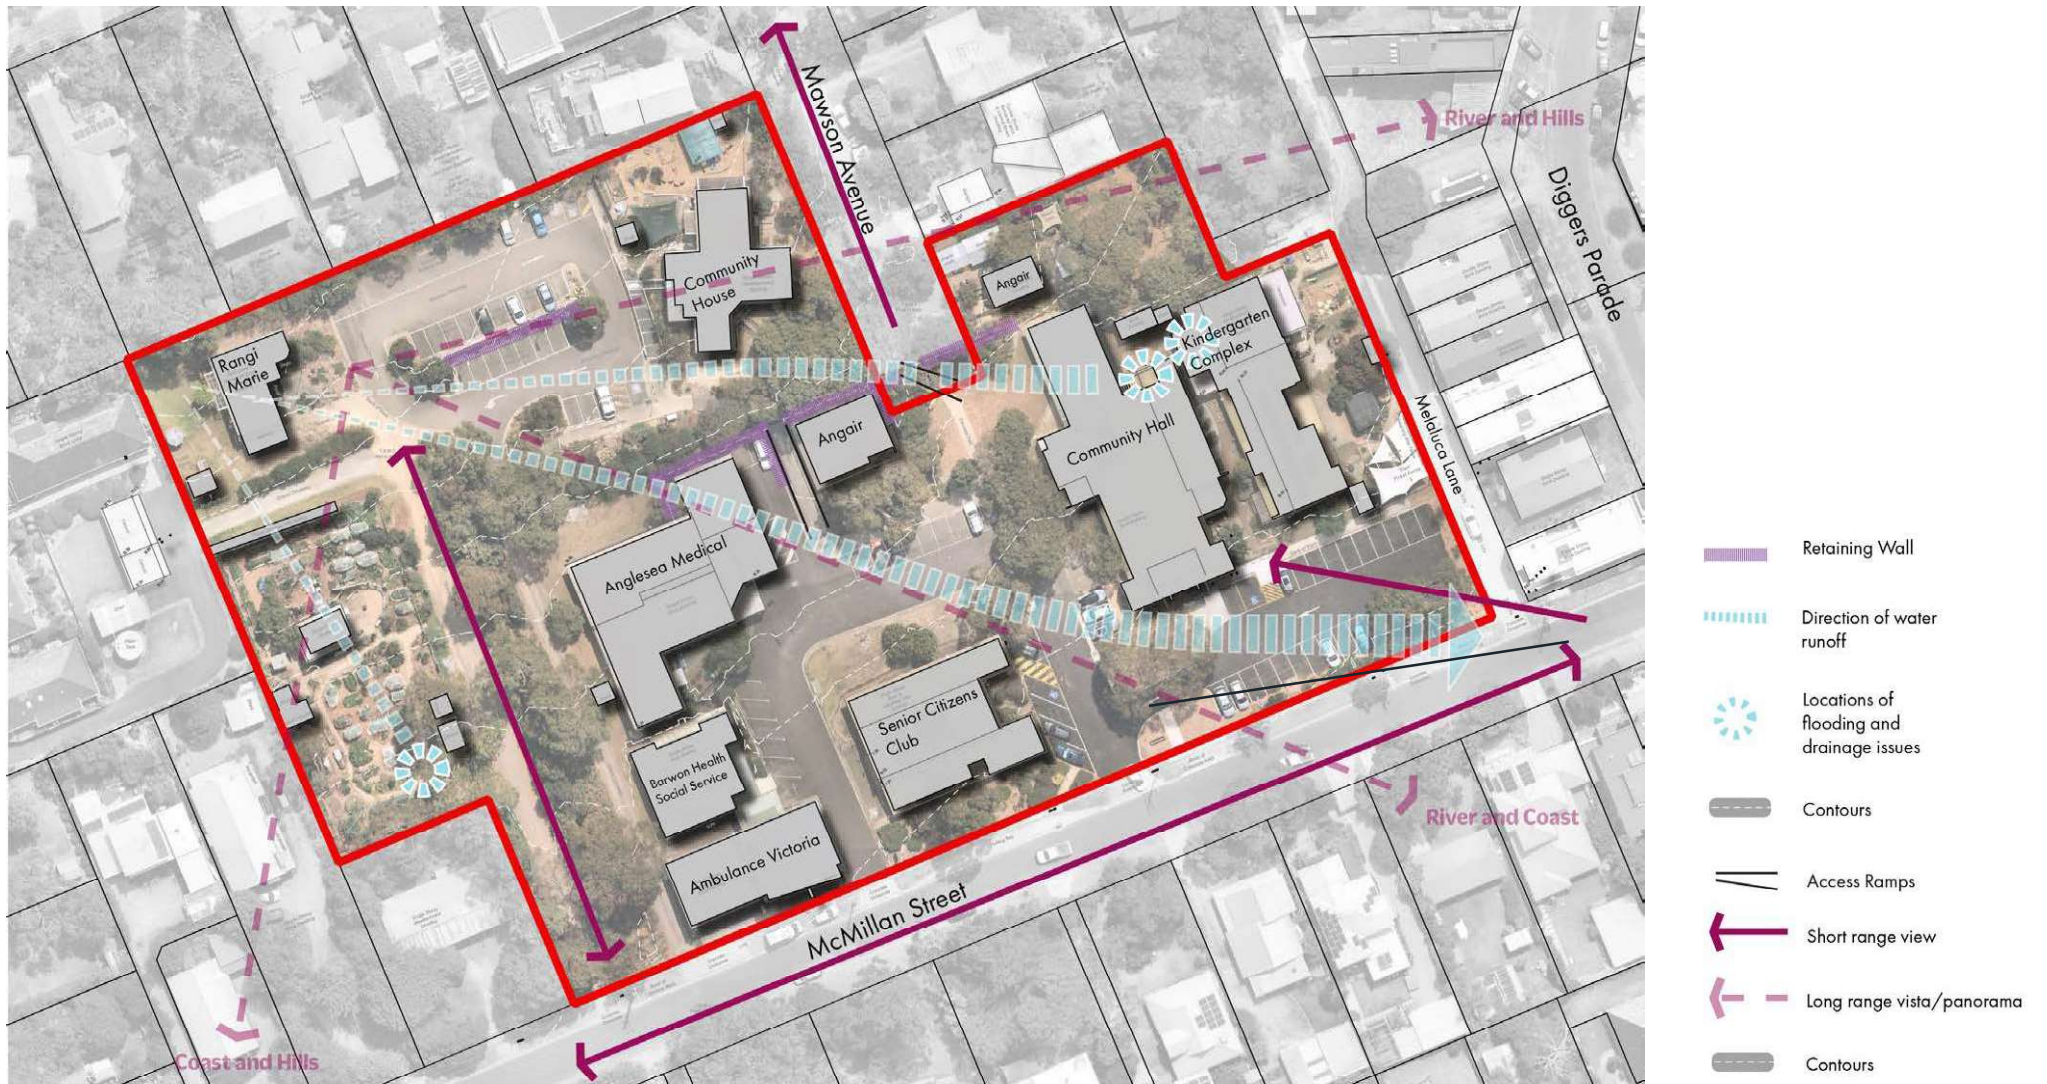
Figure 19. Topography and Views

Views into the site are provided predominantly from McMillan Street, which provides visibility to the Community Hall and other buildings. There are opportunities to enhance this frontage.

Another public viewing location is provided from the end of Mawson Street. This view is characterised by low scale buildings and natural landscape elements including trees, native grasses and gravel pathways.

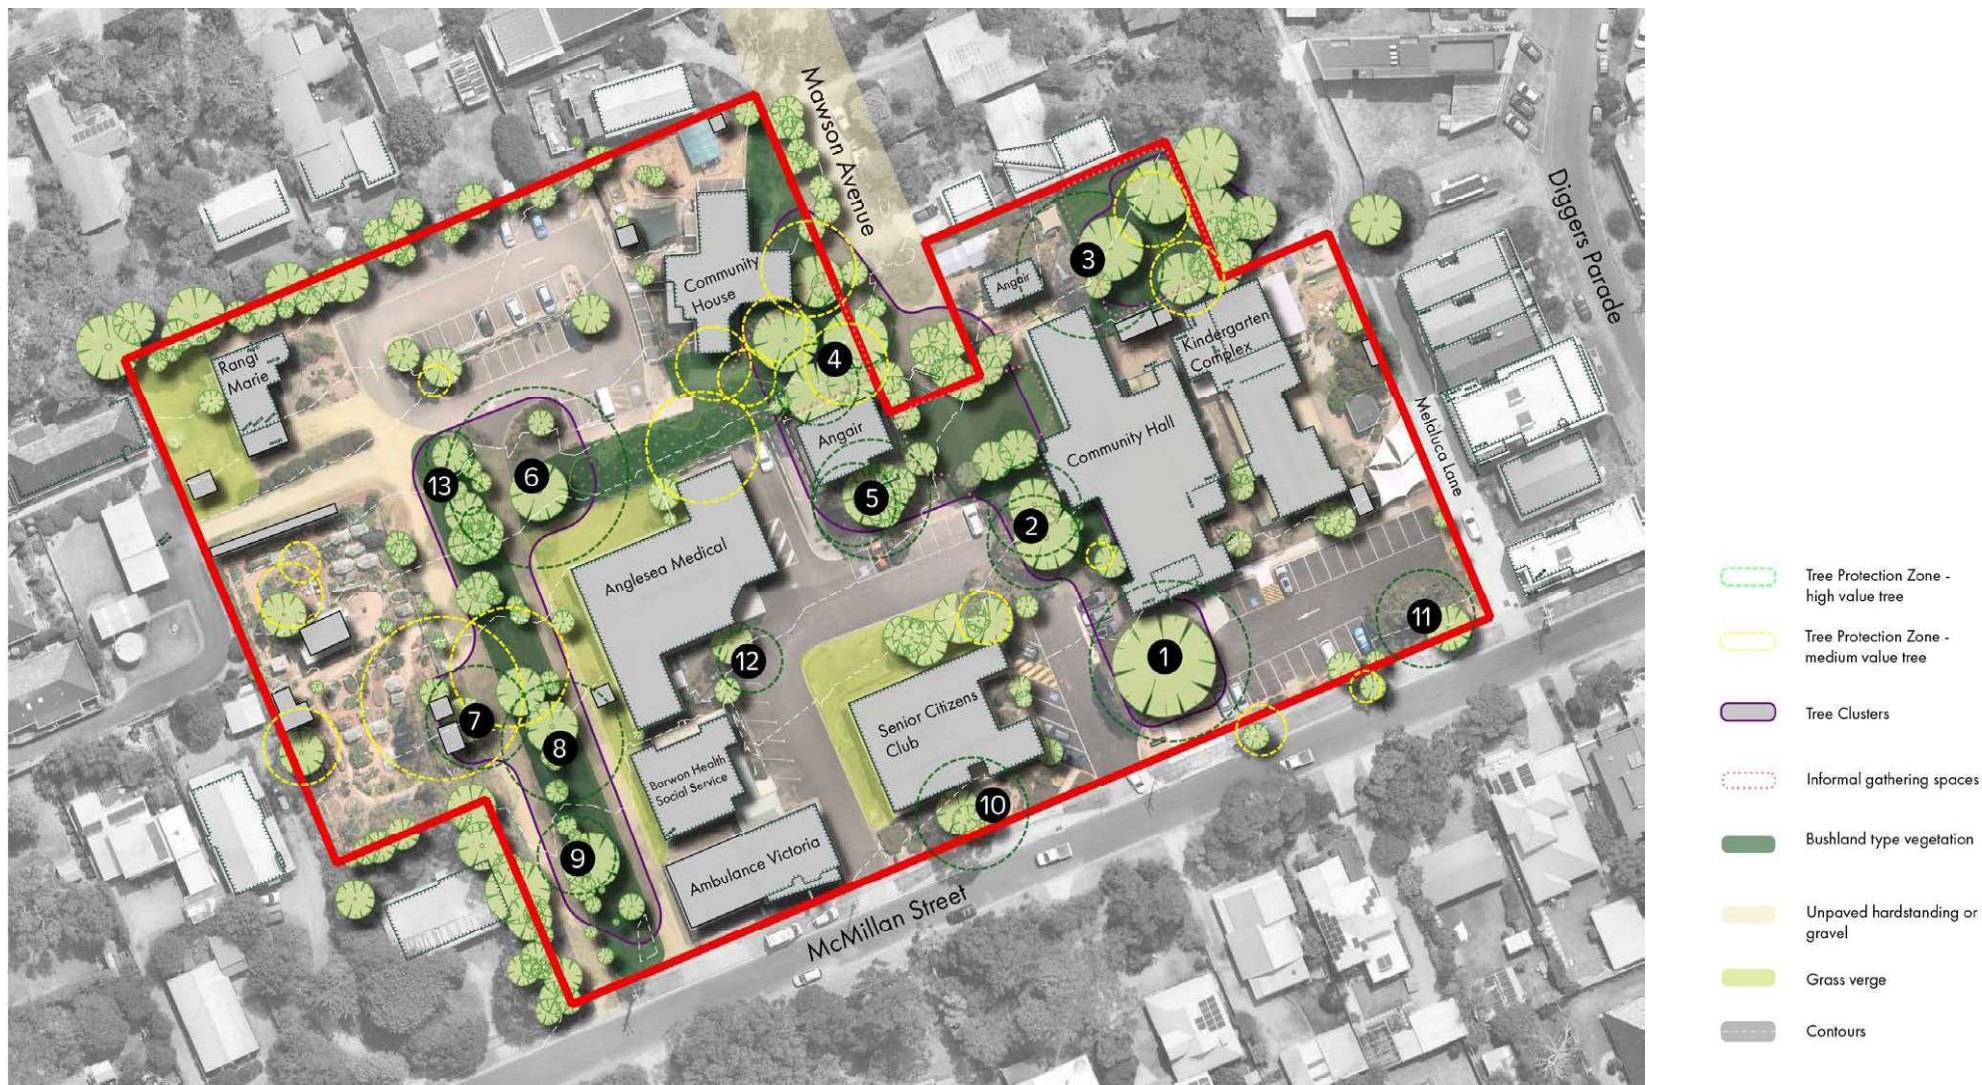
Figure 20. Landscape and Vegetation

7. An English Oak on the eastern edge of the Community Garden, 11 metre TPZ
 8. A Gippsland Manna Gum located between the two one-directional gravel roads, 18 metre TPZ
 9. A Swamp Gum located between the two one-directional gravel roads, 14 metre TPZ
 10. Two Manna Gums on McMillan Street in front of the Senior Citizens Club House, 1 metre TPZ
 11. A Manna Gum on McMillan Street in front of the Kindergarten, 11 metre TPZ
 12. A Weeping Bottlebrush at the entrance to Anglesea Medical Centre, 6 metre TPZ
- Between the Community Garden and the rear Car Park are a Gippsland Manna Gum (12 metre TPZ,) a Manna Gum (9 metre TPZ) and a Moonah (4 metre TPZ).A Weeping Bottlebrush at the entrance to Anglesea Medical Centre, 6 metre TPZ

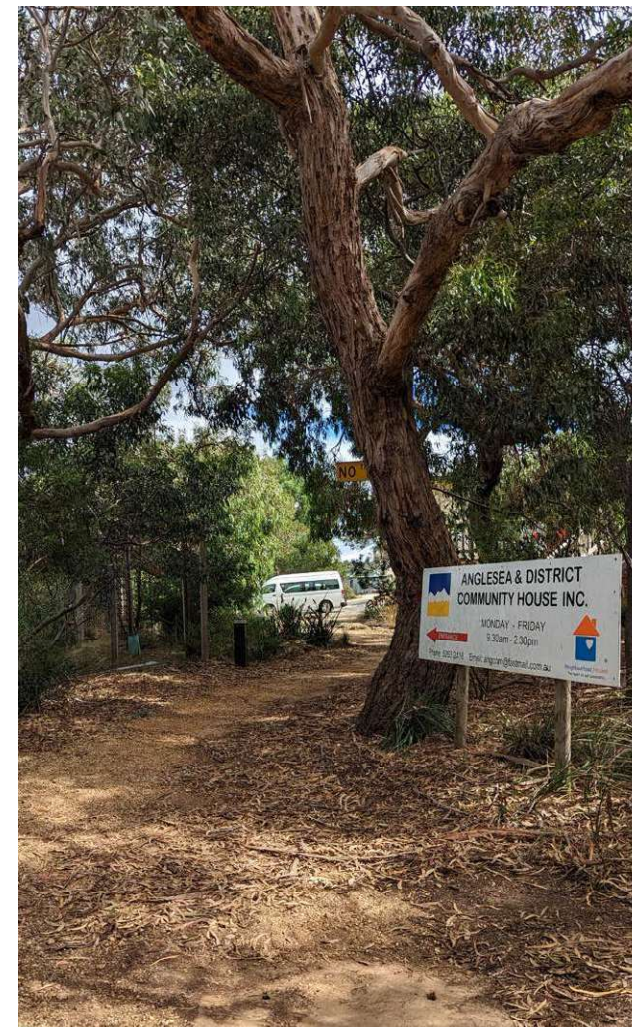
Large tree to the front of the Anglesea Community House

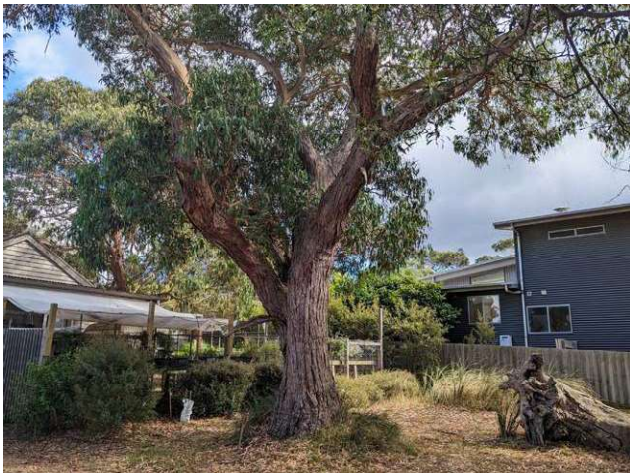
Large tree to the rear of the Community Hall and Angair Plant Propagation Unit

1. A large Manna Gum out the front of the Community Hall, 14 metre TPZ
2. Two Manna Gums to the west of the Community Hall , 14 metre TPZ each
3. A large Manna Gum at the rear of the Angair Plant Propagation Unit, 14 metre TPZ
4. A Southern Blue Gum (18 metre TPZ) and a Manna Gum (13 metre TPZ) positioned between the Anglesea Community House and Angair's Office and Meeting Room
5. Two Mann a Gums at the front of Angair's Office and Meeting Room, one 14 metre TPZ and one 6 metre TPZ
6. A Manna Gum located between Anglesea Medical Centre and the rear car park, 14 metre TPZ

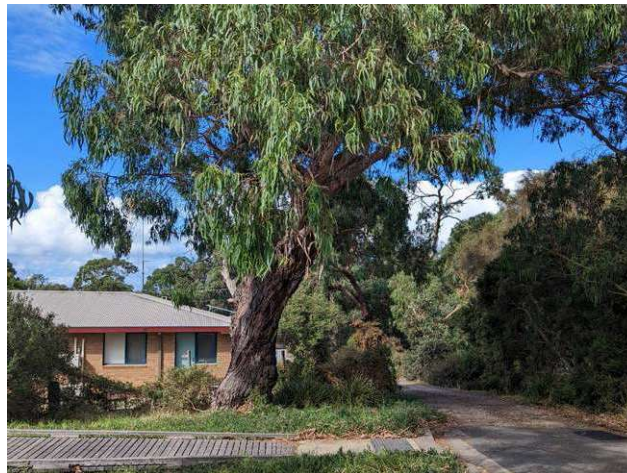
Large tree to the rear of the Anglesea Medical Centre

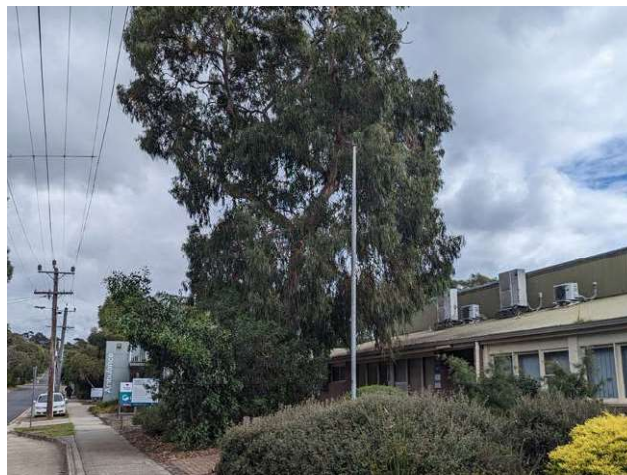
Tree to the front of the Senior Citizens' Club House on McMillan Street

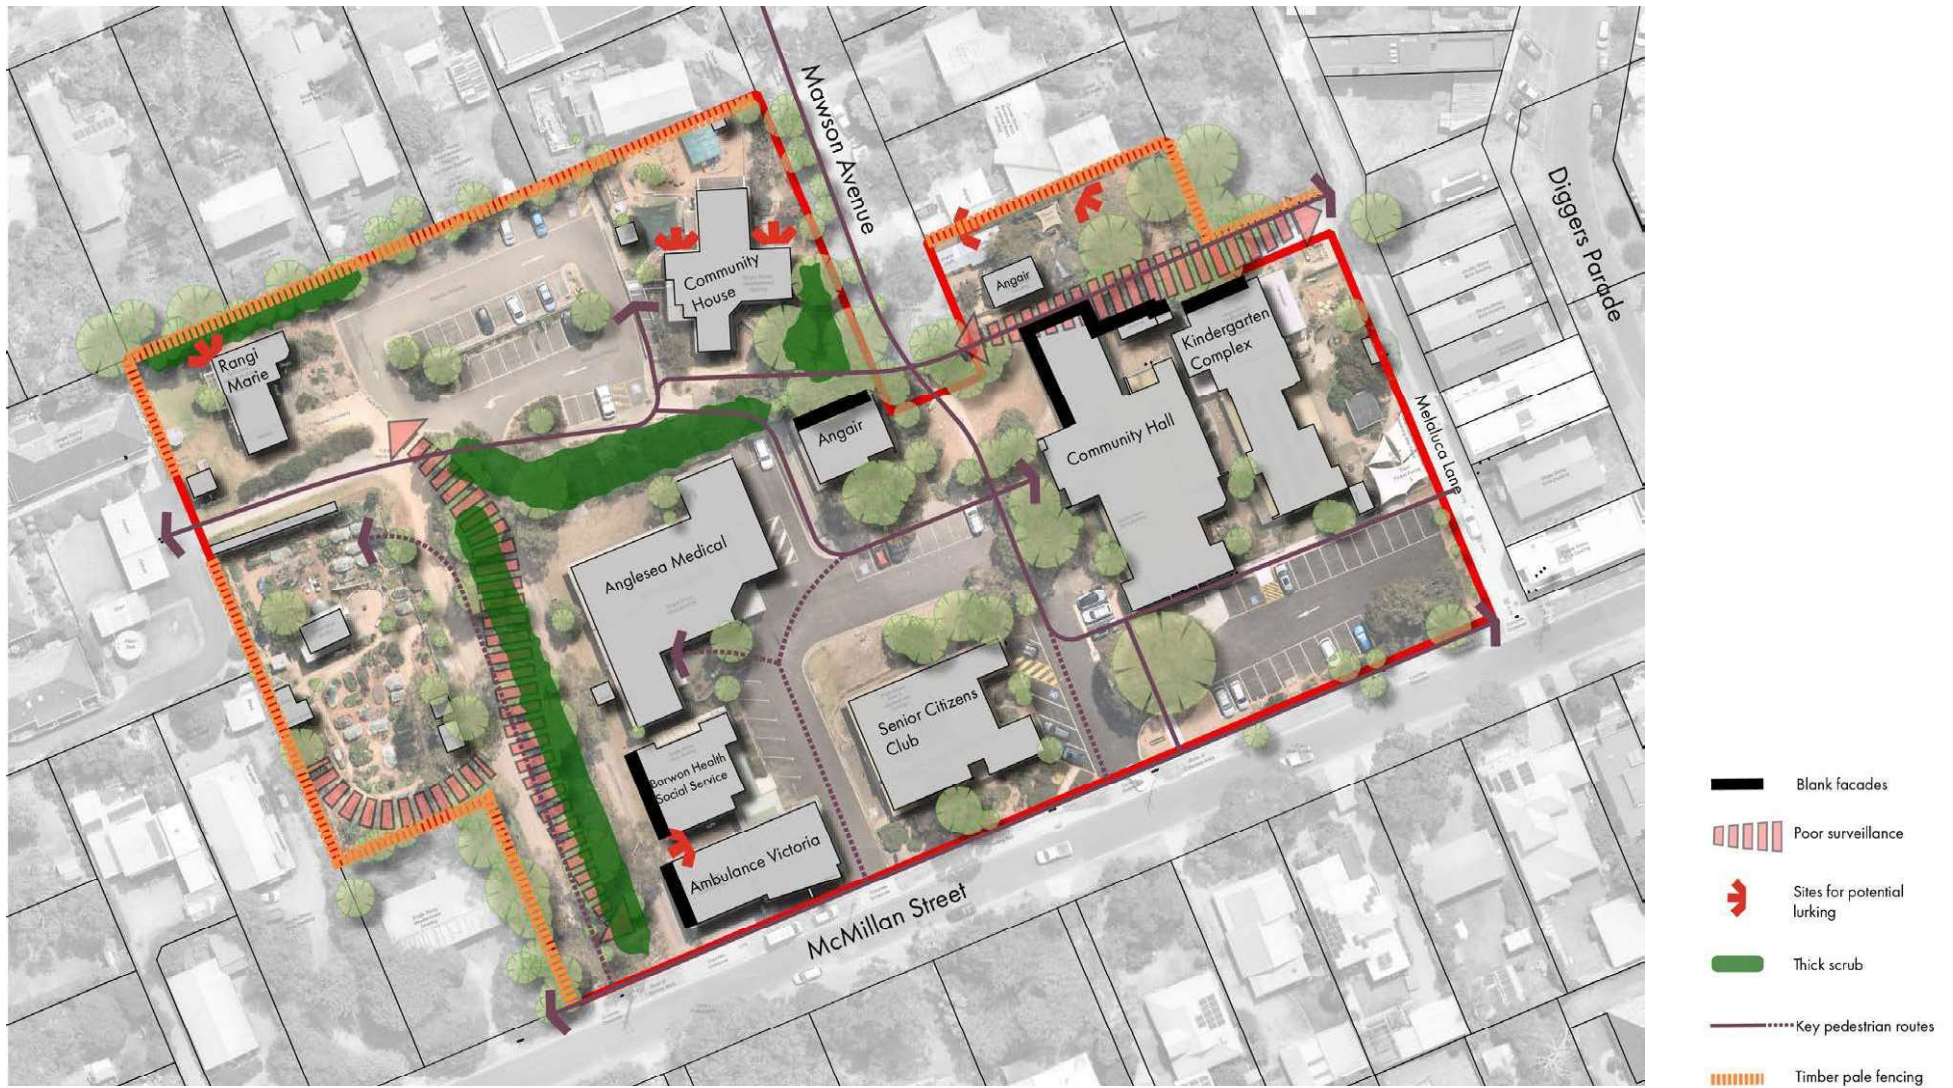
Figure 21. CPTED Analysis

- Visibility and surveillance is compounded by this vegetation, particularly of any movement and activity at the rear of the site, when viewed from McMillan Street up the two one-directional gravel roads.

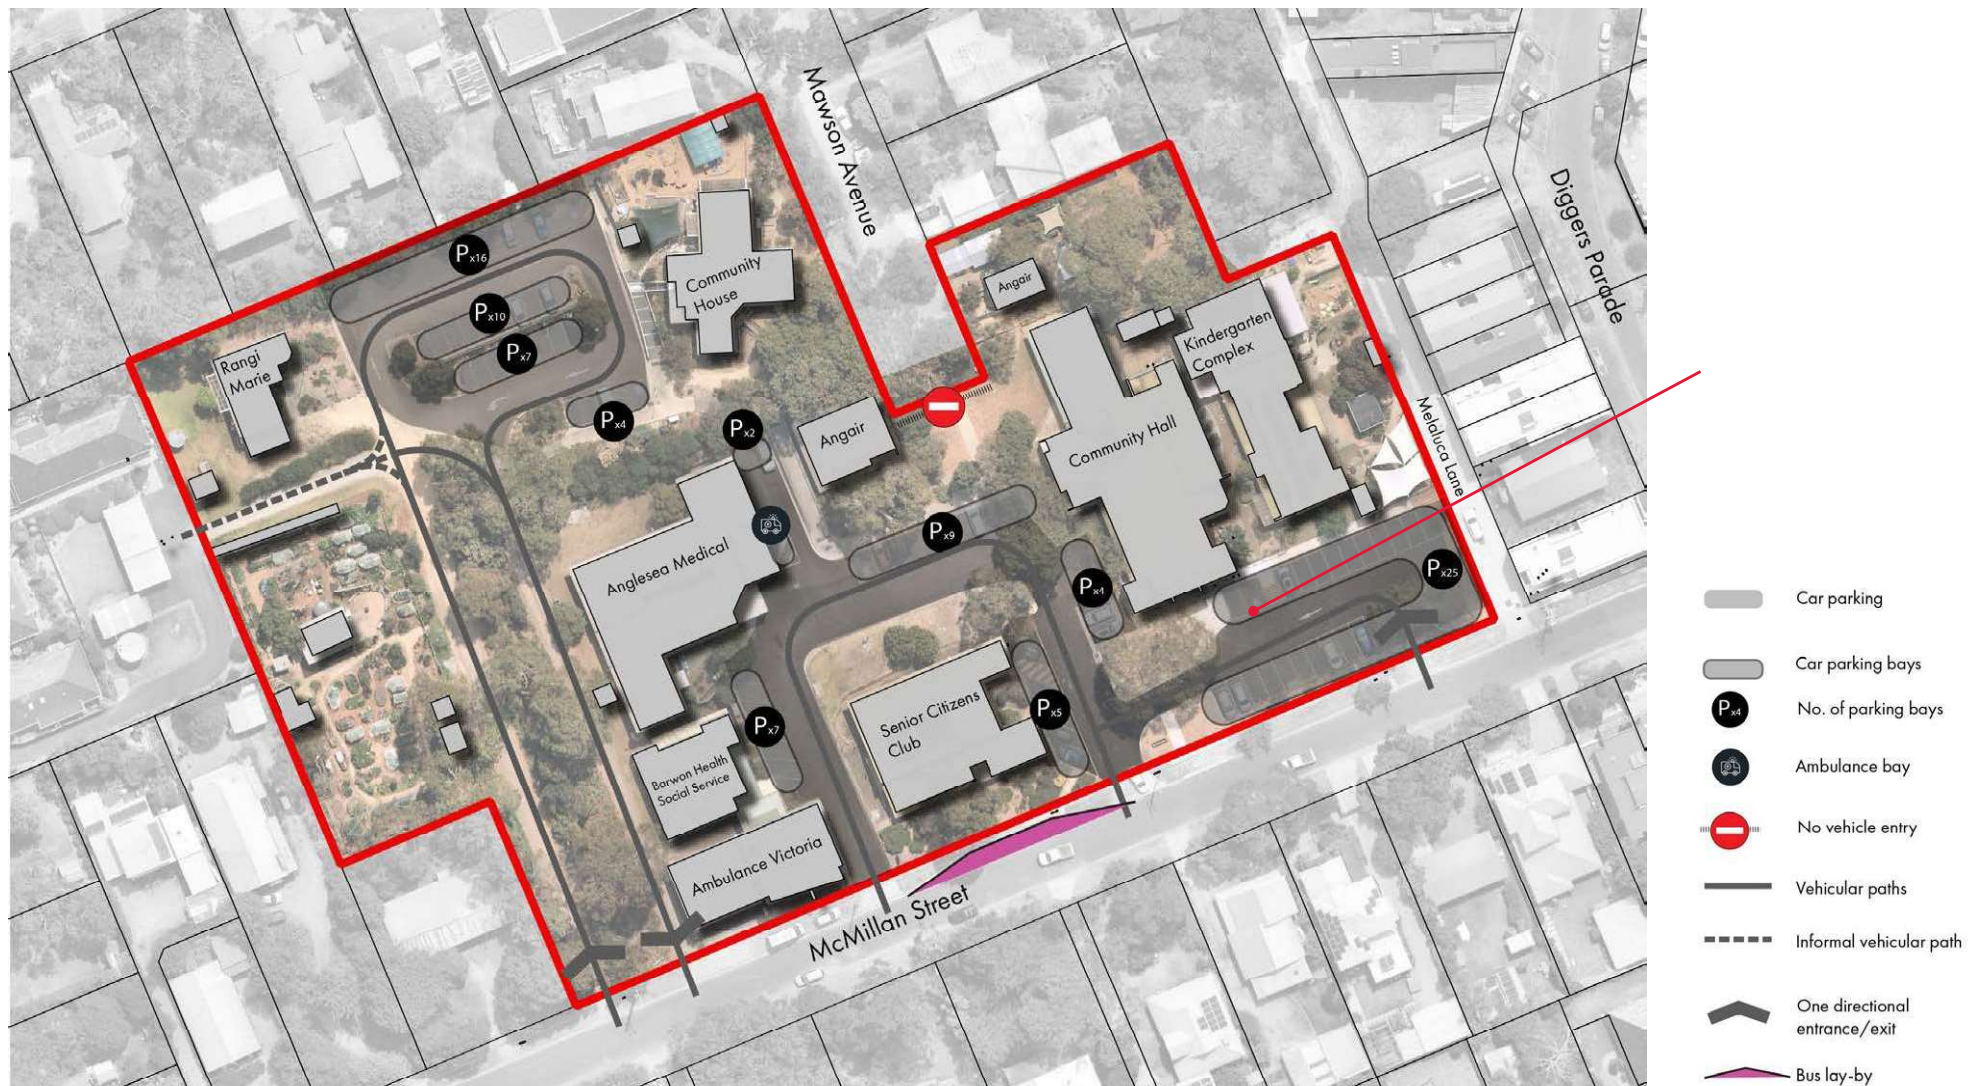
Figure 23. Vehicle Access and Parking

Surface car parking is located on paved hardstanding found in two key clusters on the Site. The total area given to car parking makes up just under a quarter of the total site area (21.2%).

This horseshoe shaped circulation route provides shared vehicular and pedestrian access to Anglesea Medical Centre leading to a significant amount of intermingling of pedestrians and cars and may pose a hazard.

Loading and waste collection activities are understood to be carried out via private contractors on-site and within the internal road network. Deliveries are anticipated to be completed by small delivery vans or service vehicles. Access for loading and waste collection vehicles is anticipated to be completed via the two-way crossovers adjacent the Senior Citizens building.
